Six Street Viaduct Over the Los Angeles River (Bridge No. 53C-1880)
Phase II Material Testing Final Report
February 7, 2002

Figure 1: Overall view of Sixth Street Viaduct looking north between Bents 7 and 19.

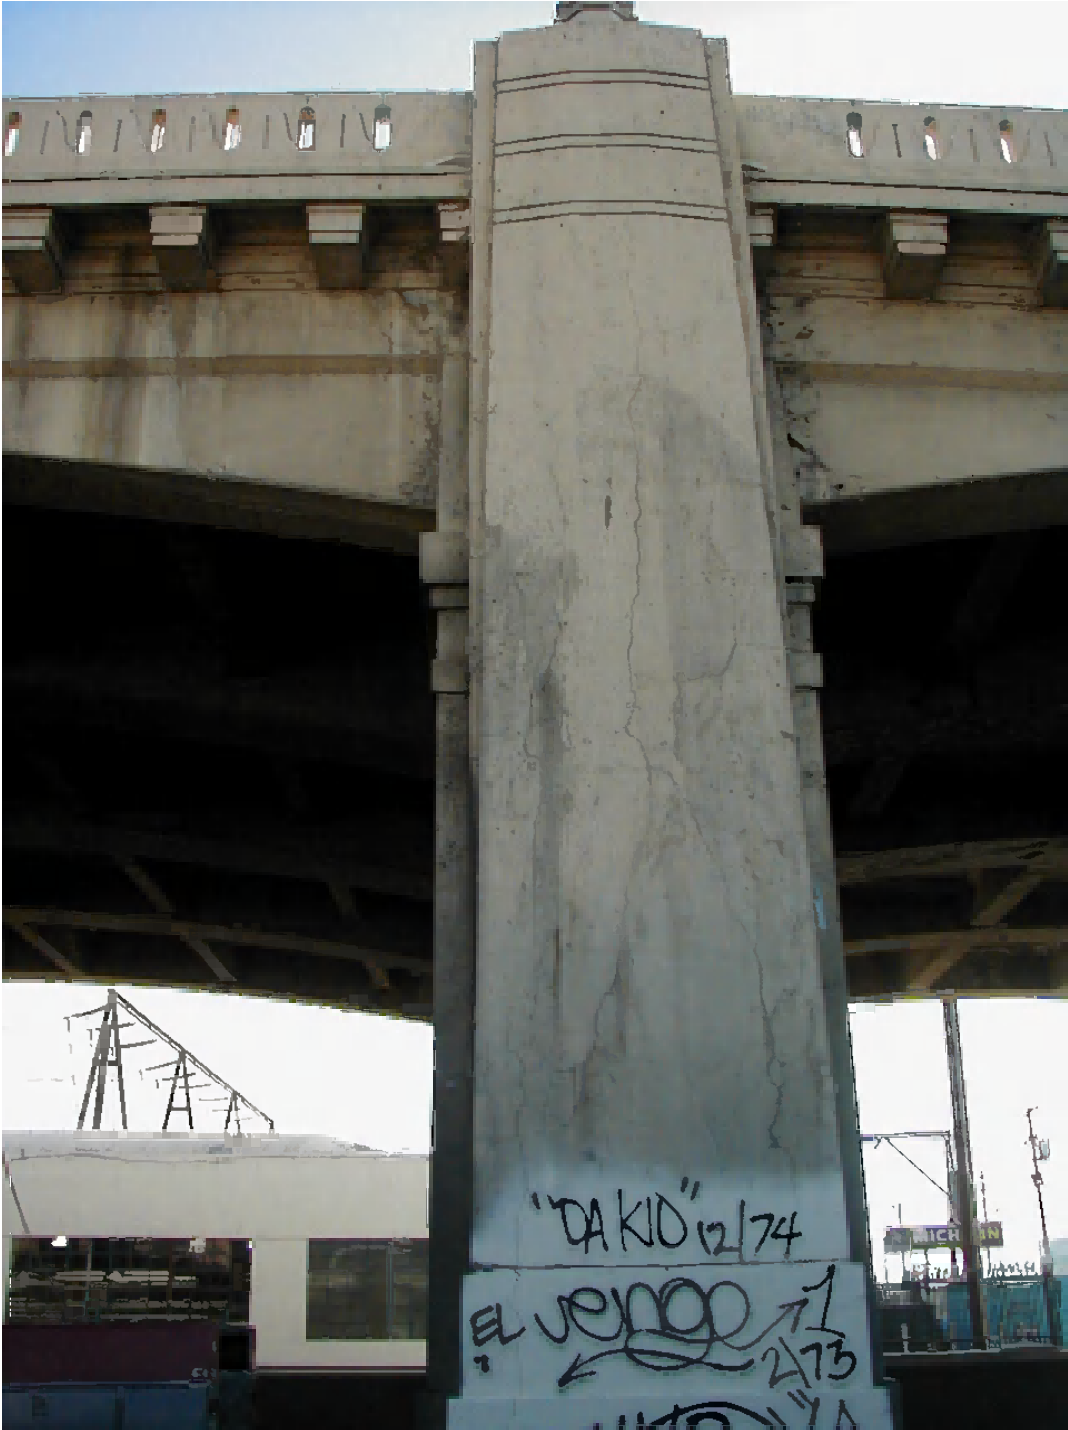
Figure 5: Typical cracking on outside face of column.

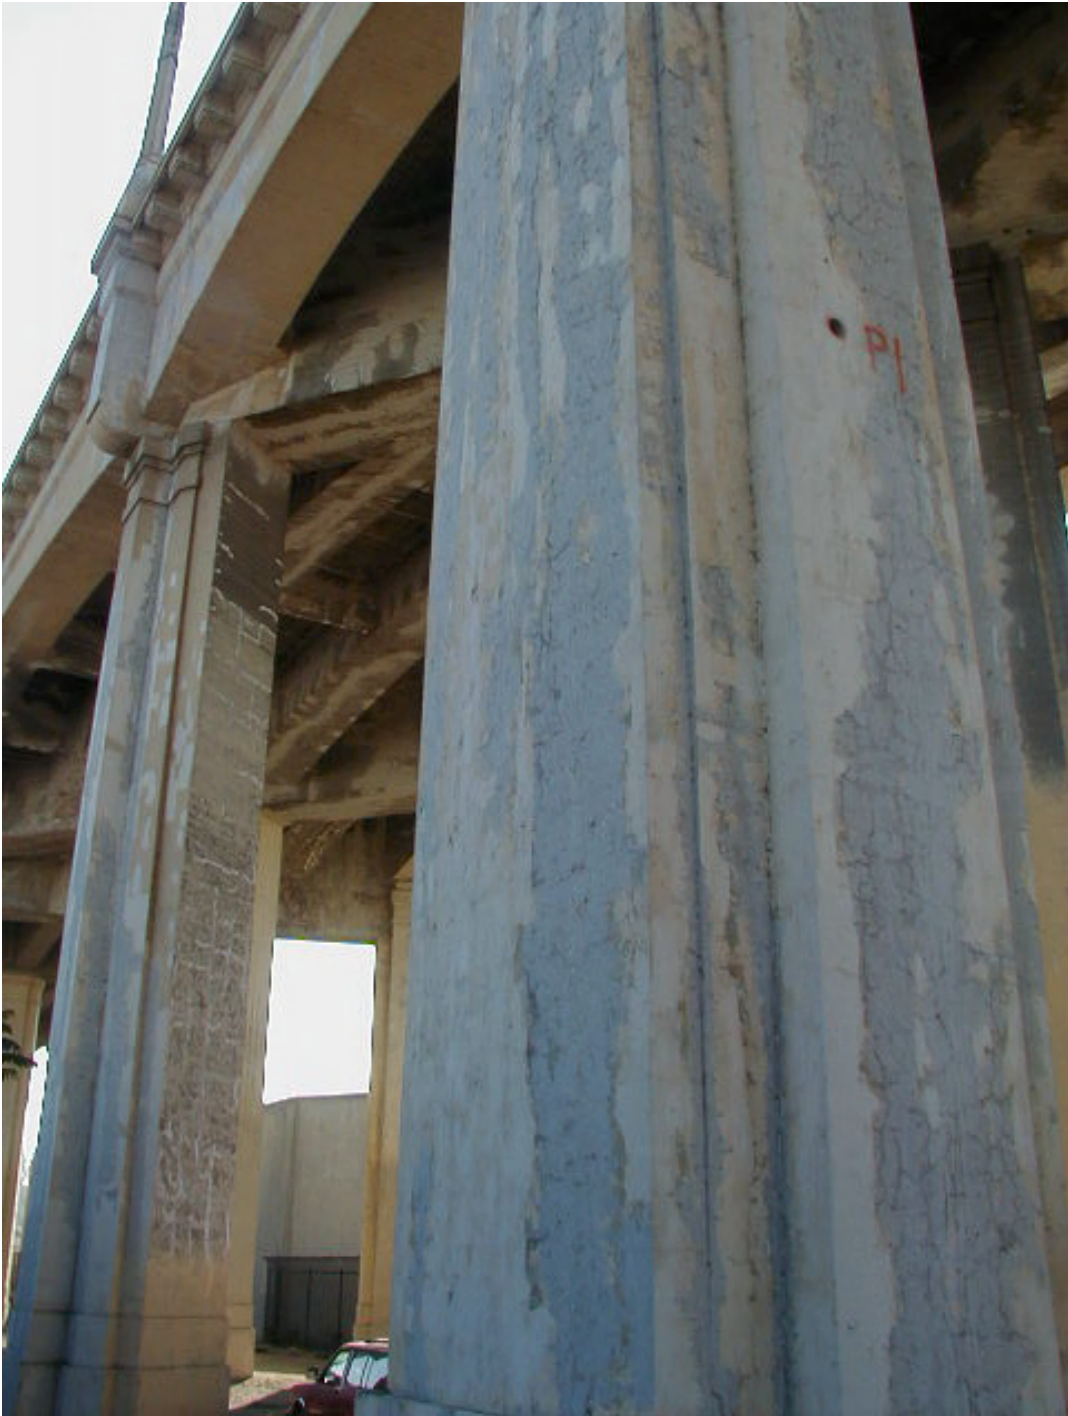
Figure 6: Typical condition of columns at east end of bridge.

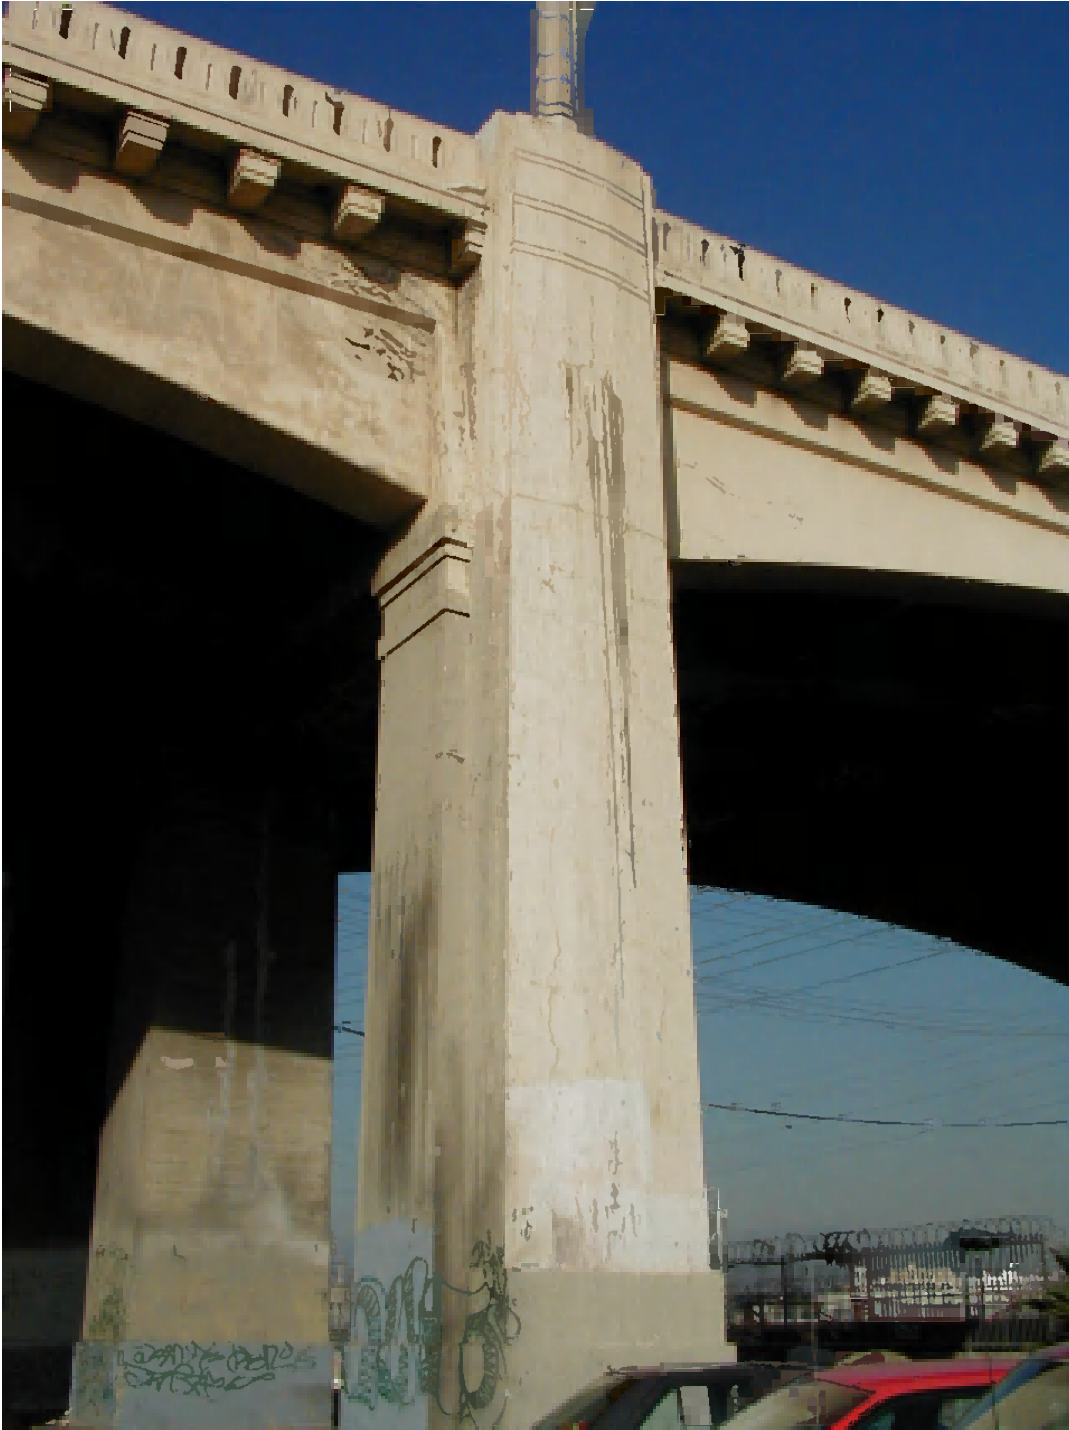
Figure 7: Typical horizontal crack in column at level of bent cap.

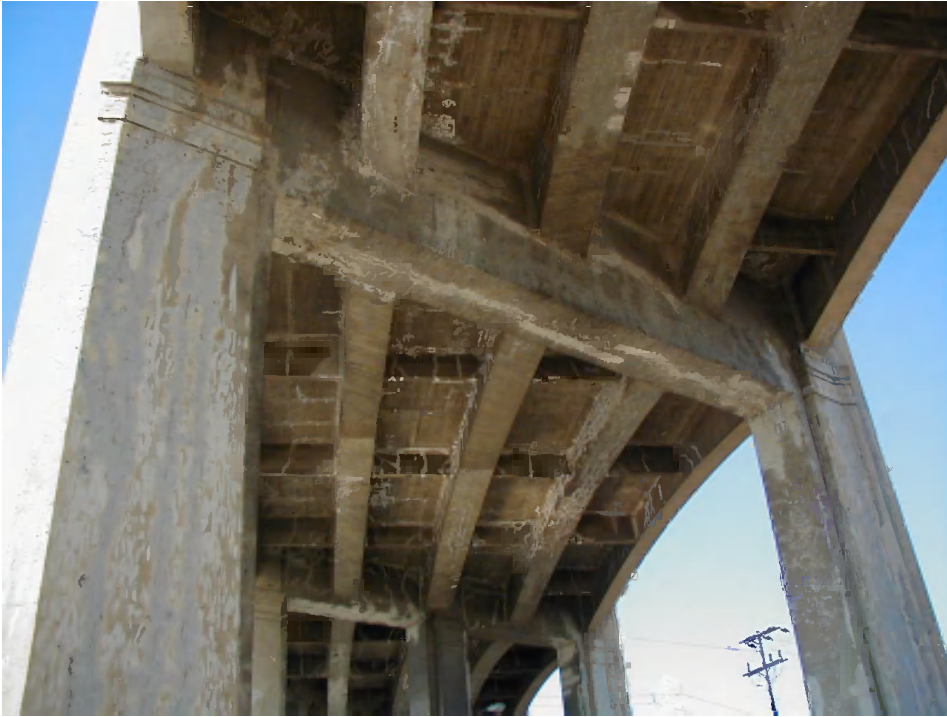
Figure 8: Typical cracking pattern in bent cap and girders.

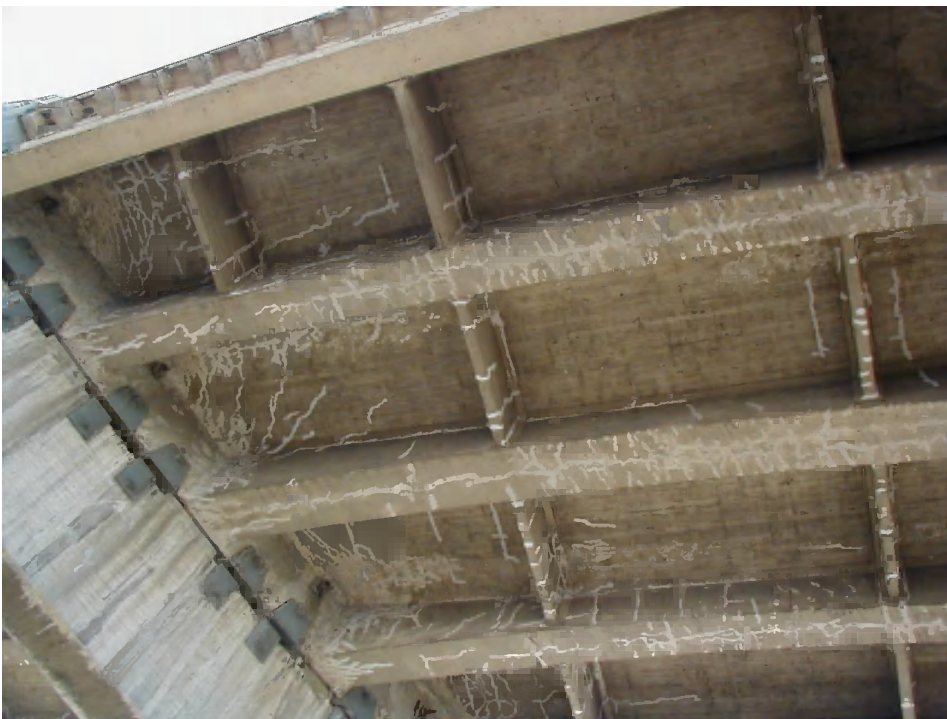
Figure 9: Typical crack patterns noted in girders.

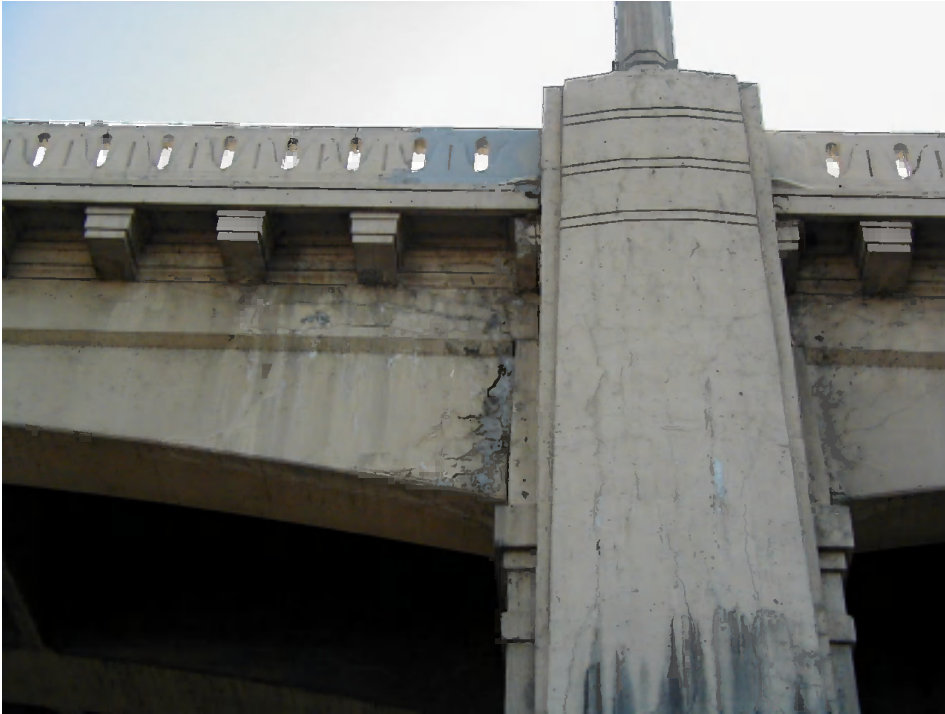
Figure 10: Peeling paint and longitudinal web cracking in girders.

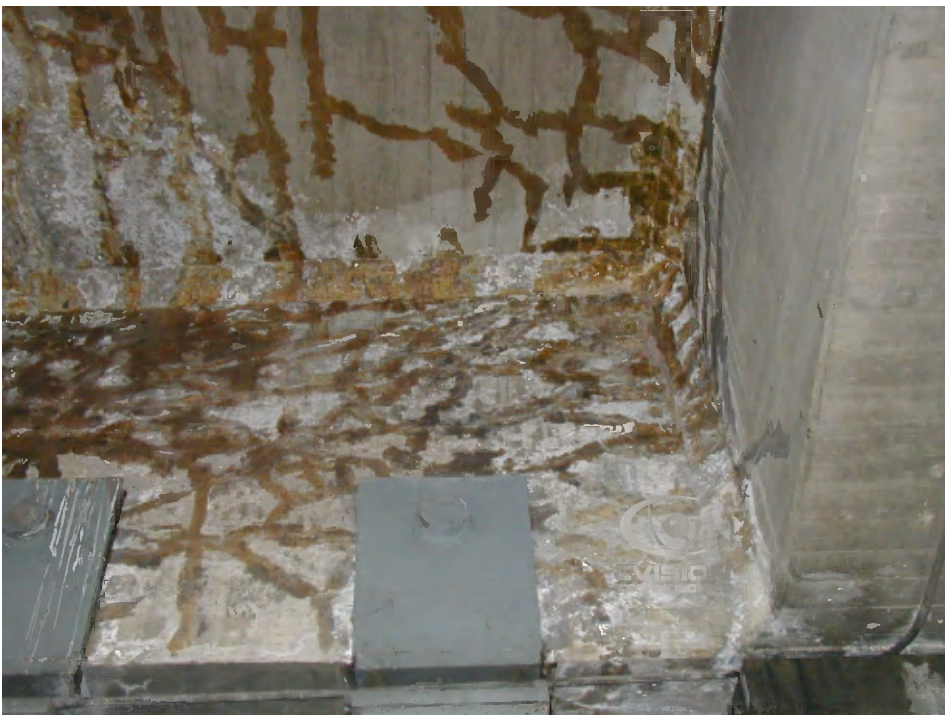
Figure 11: Severe cracking in bent cap and deck soffit. Note the efflorescence in the deck.

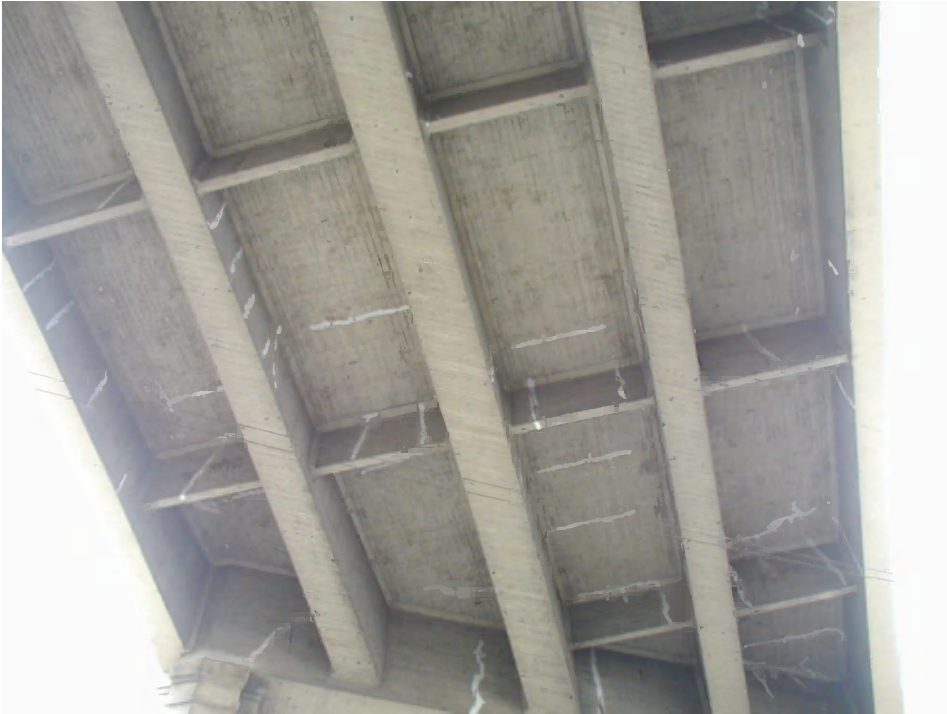
Figure 12: Typical crack pattern on deck and girder at lightly distressed locations at the east end

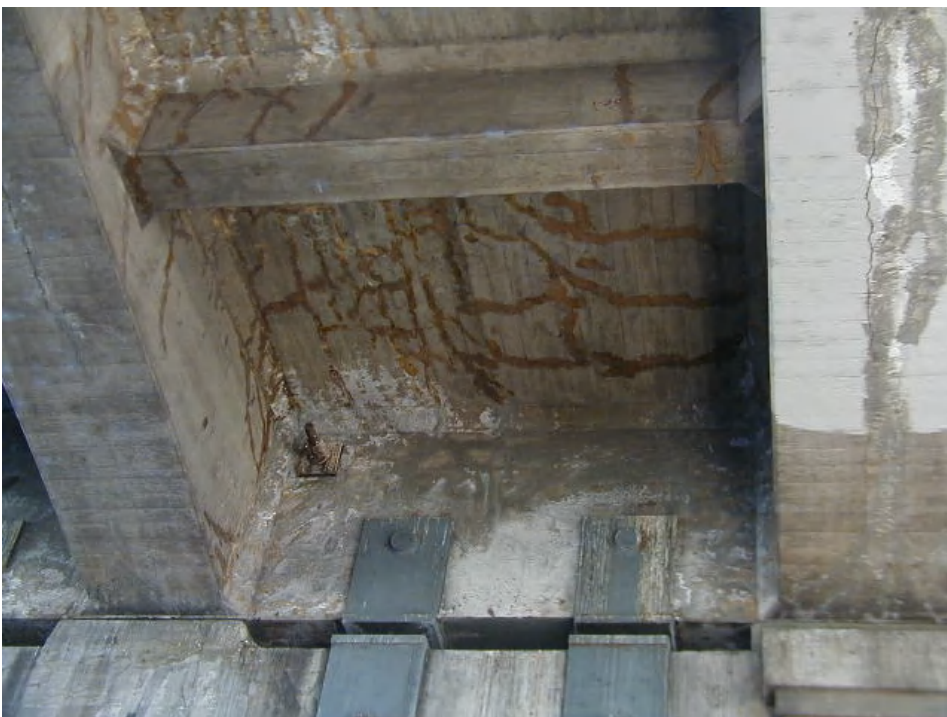
Figure 13: Dense map cracking in deck soffit at bent cap.

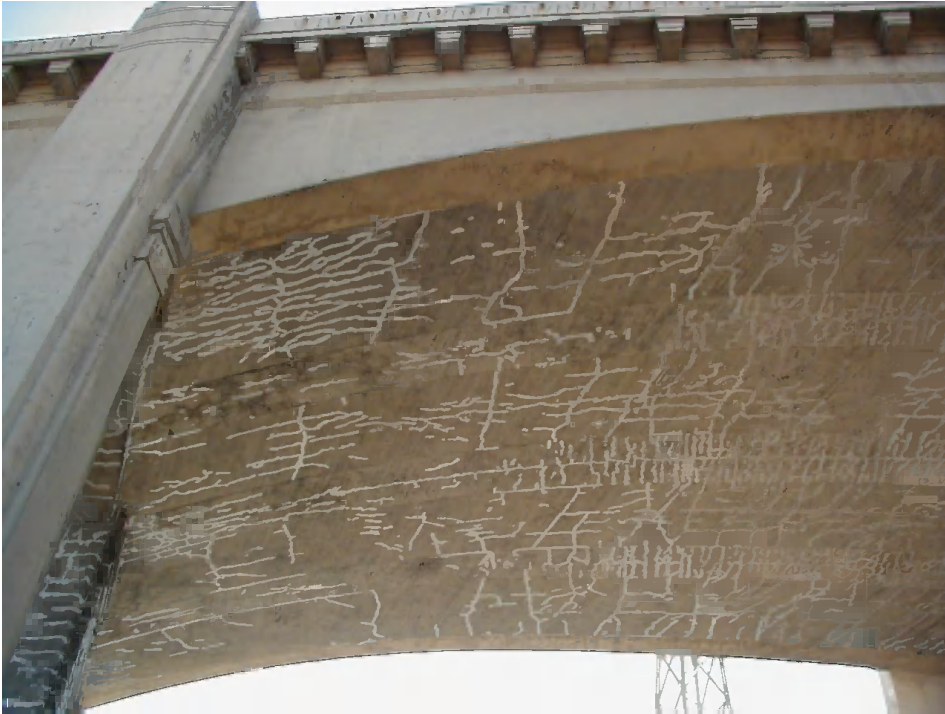
Figure 14: Map cracking in the infill soffit of girders at bays over railroad tracks.

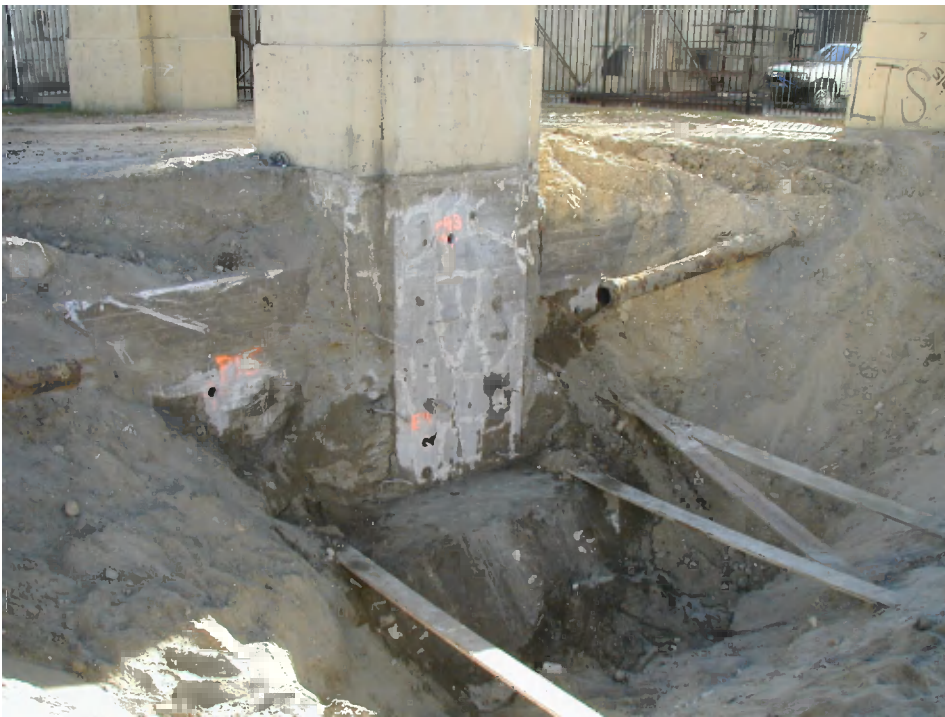
Figure 15: Excavation and core locations at Bent 23.

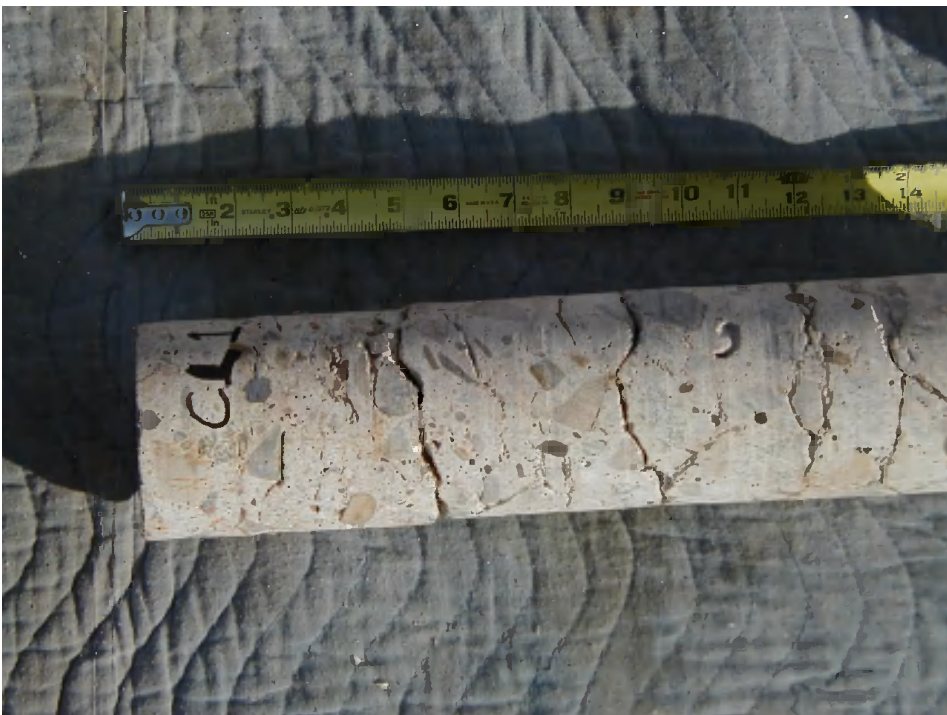
Figure 17: Typical pattern of network cracking seen in severely cracked cores.

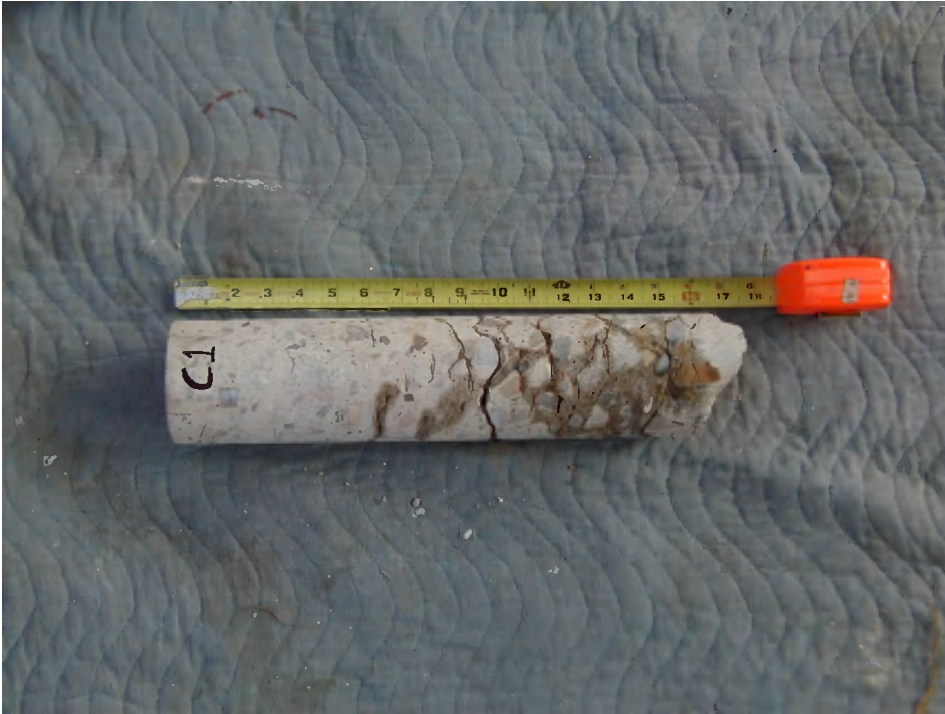
Figure 18: Network cracking was typically more severe deeper in the core than near the surface of the concrete.

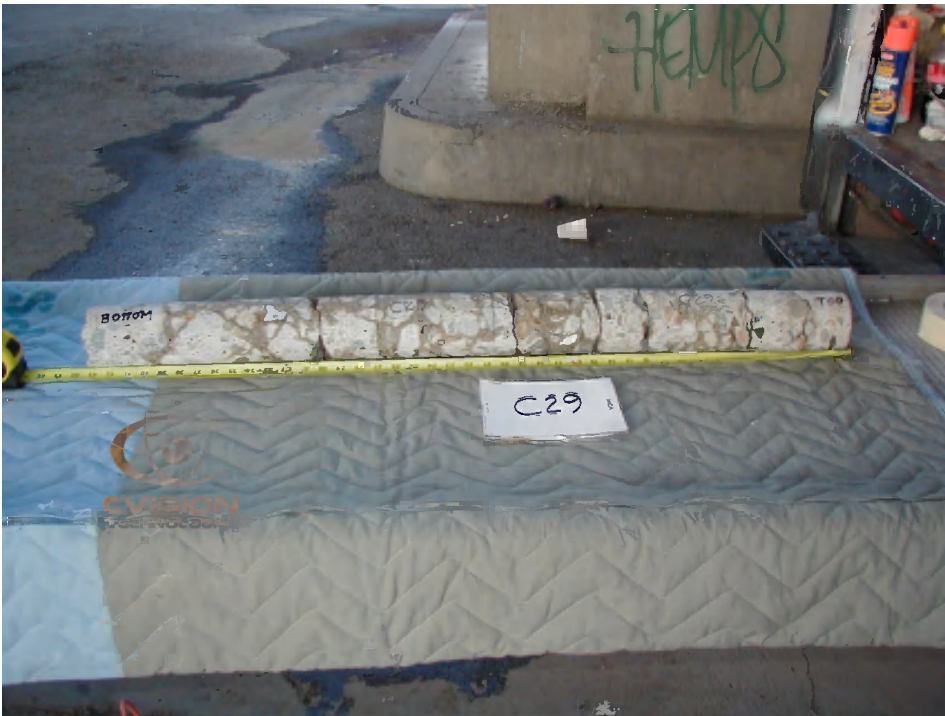
Figure 19: Severely cracked core that had 6 breaks when removed from a column.

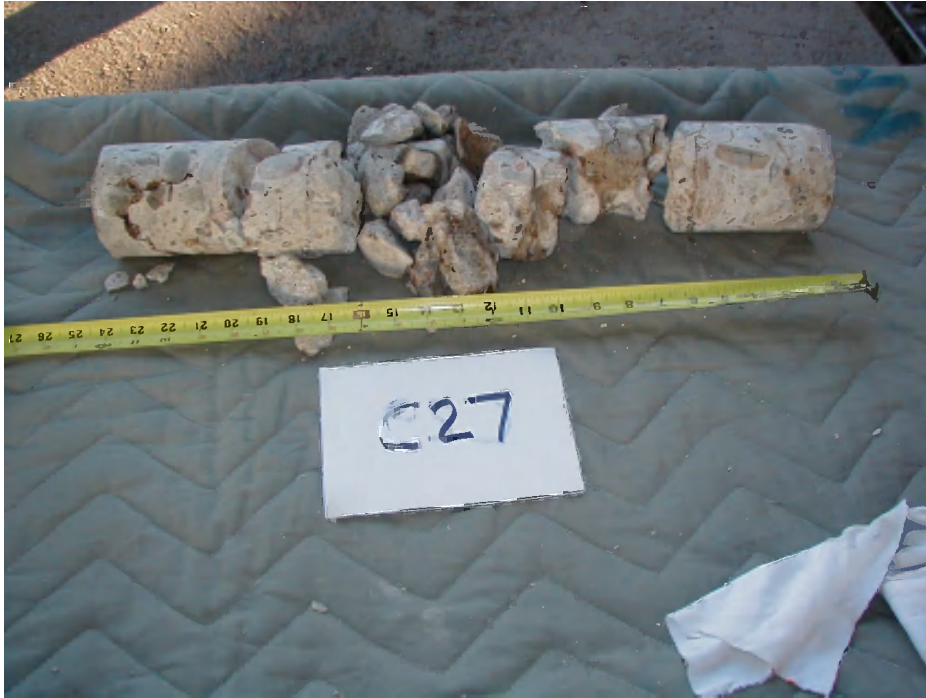
Figure 20: Internal cracking so severe that core broke into rubble during extraction.

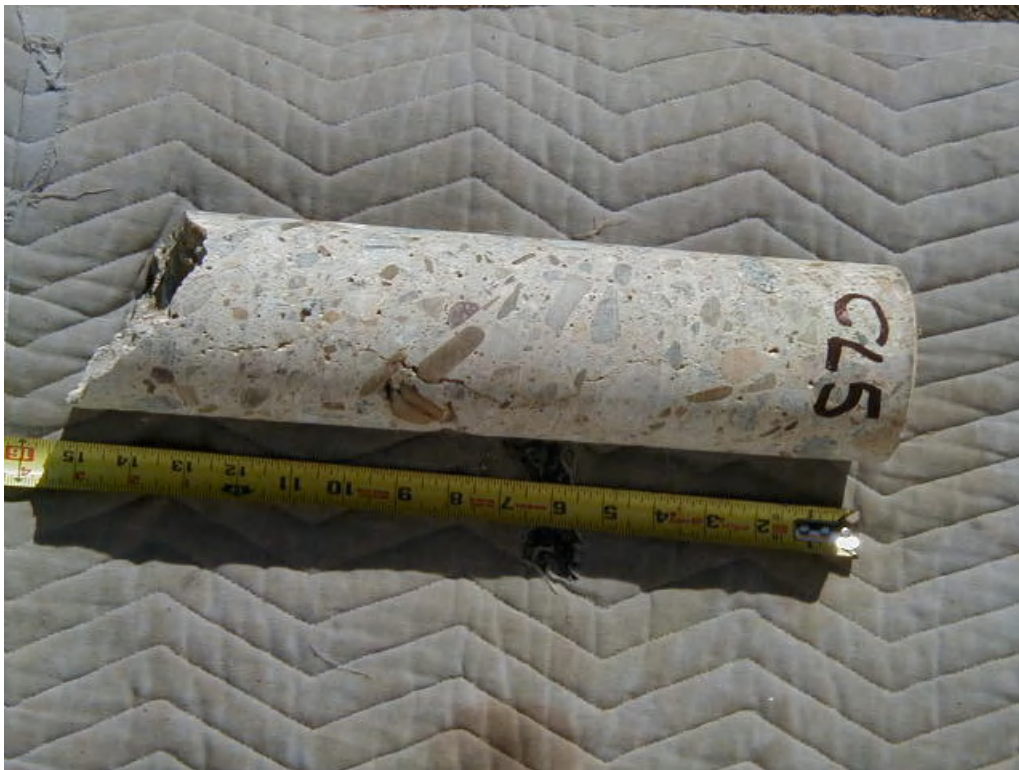
Figure 21: Example of a core with a moderate visual distress rating.
