Figure 22: Overall condition of typical bays at the most severely deteriorated sections of the bridge between Bents 12 and 30.

Figure 23: Typical condition of girders and deck soffit at west end of viaduct.

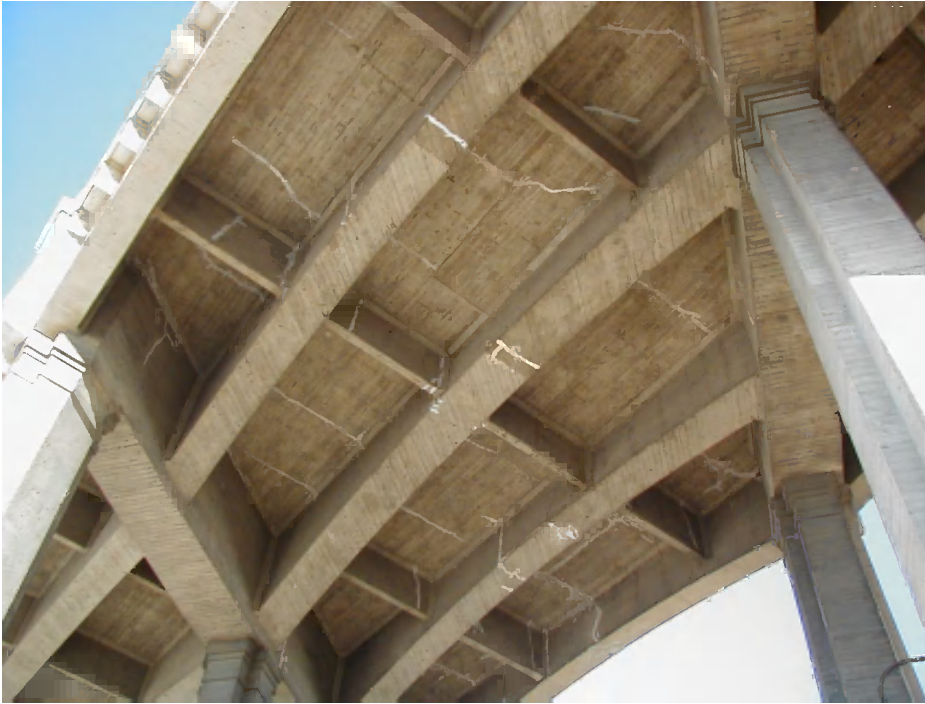
Figure 24: Typical conditions of girders and deck soffit at east end of viaduct between roughly Bents 31 through 39.

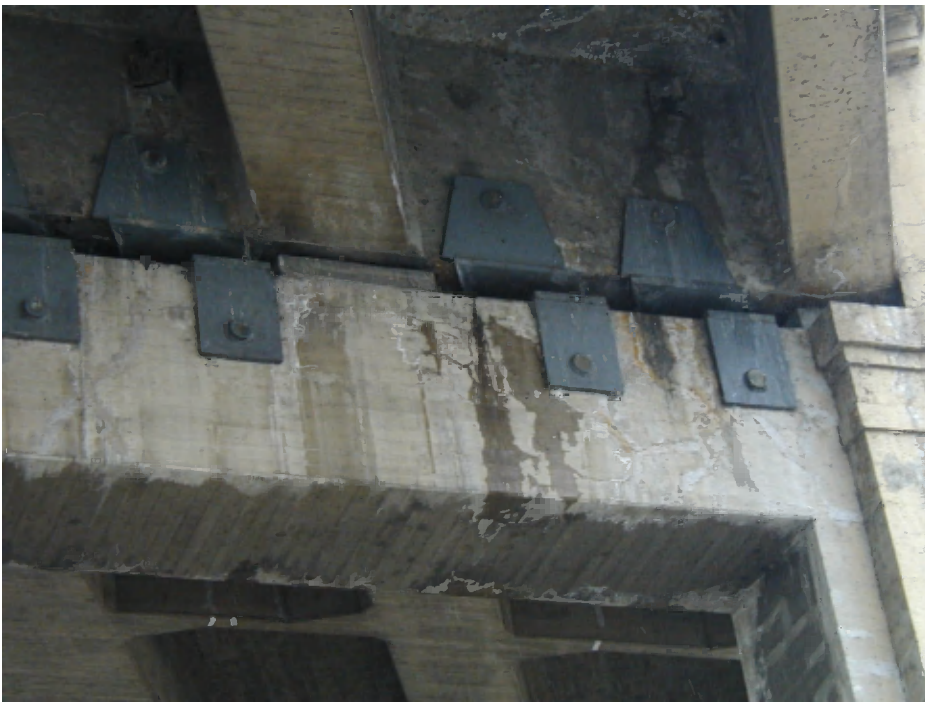
Figure 25: Leaking joint in deck deposits water on top of bent cap. Water migrates into cracks at top of member and emerges through cracks in the face.

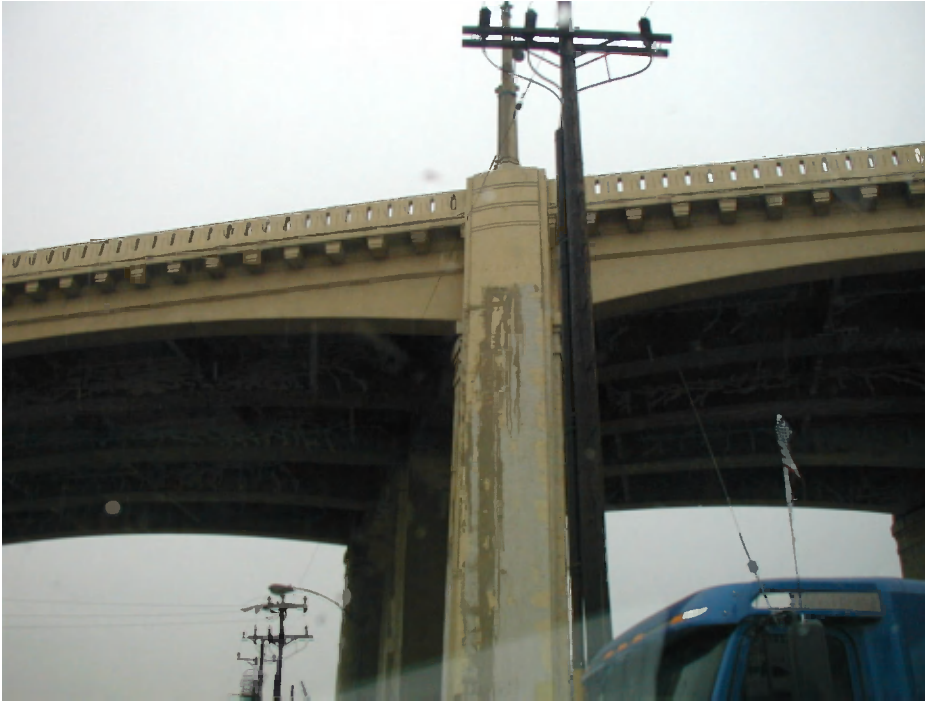
Figure 26: Water leaking from a typical horizontal column crack at bent cap.

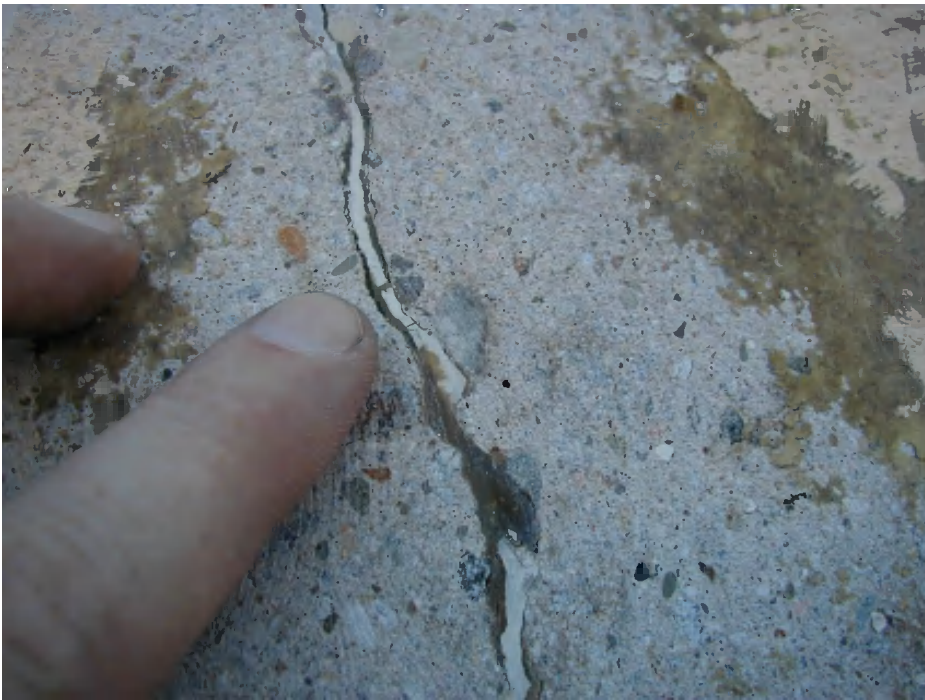
Figure 27: Crack at surface of column with two generations (colors) of epoxy injection and the crack has reopened.

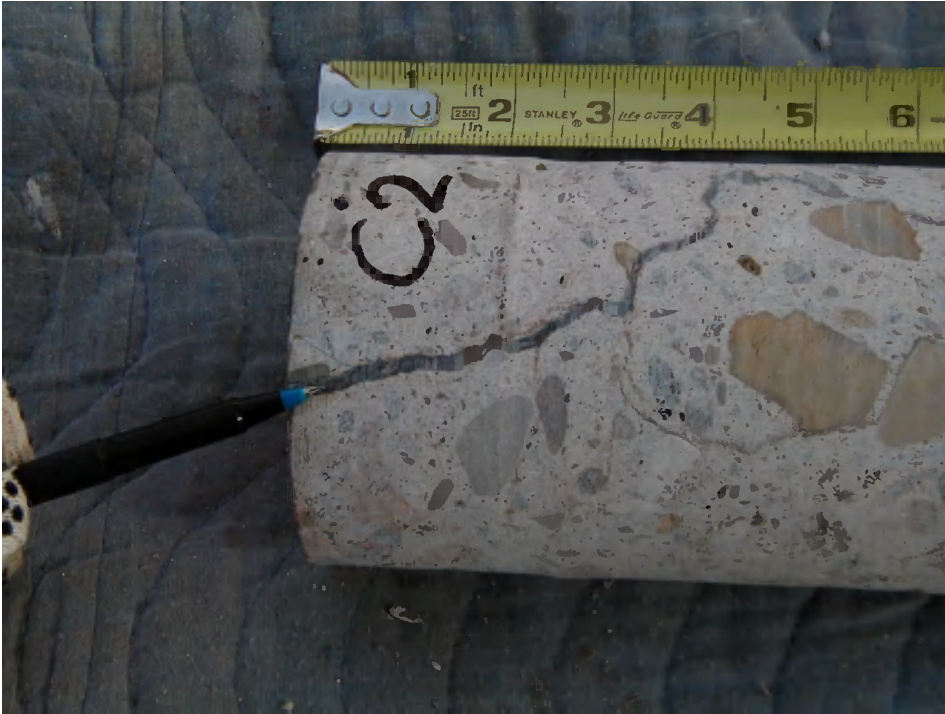
Figure 28: Core with a portion of an epoxy injected crack. Note that the fine cracks have not had penetration.

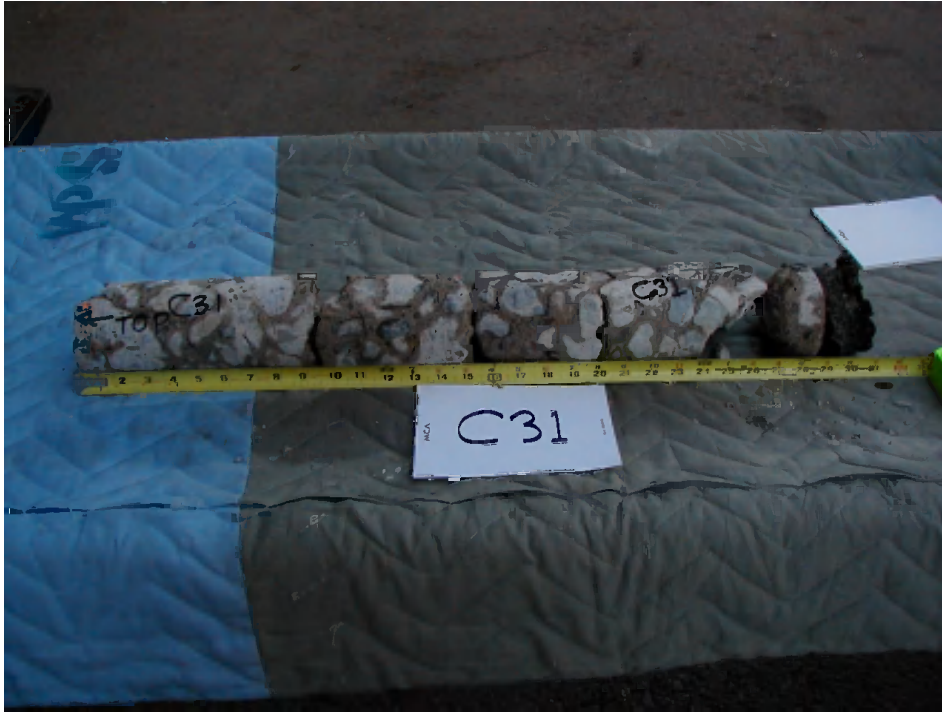
Figure 29: Severely distressed core with lowest $f'_c = 1510$ psi. Test made on portion from 1-inch to 7-inch depth. Core 31, girder diaphragm above bent cap at Bent 9.

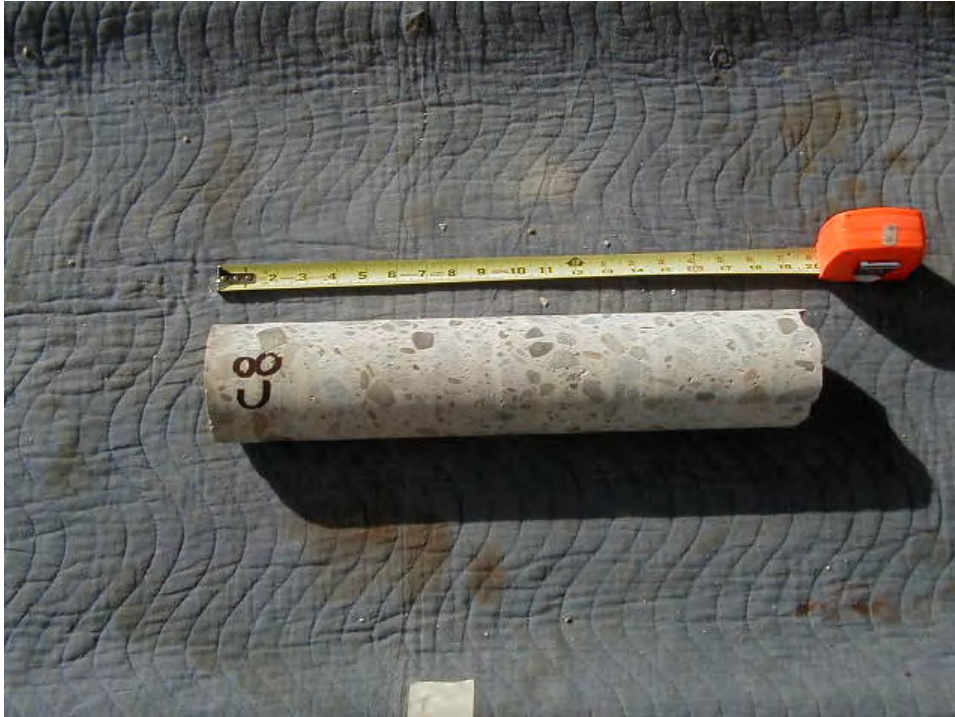
Figure 38: Core with no visible cracking that had median compressive strength value ($f'_c = 3830$ psi) of cores with light or no distress. Core was tested from 10-inch to 17 ½-inch depth.

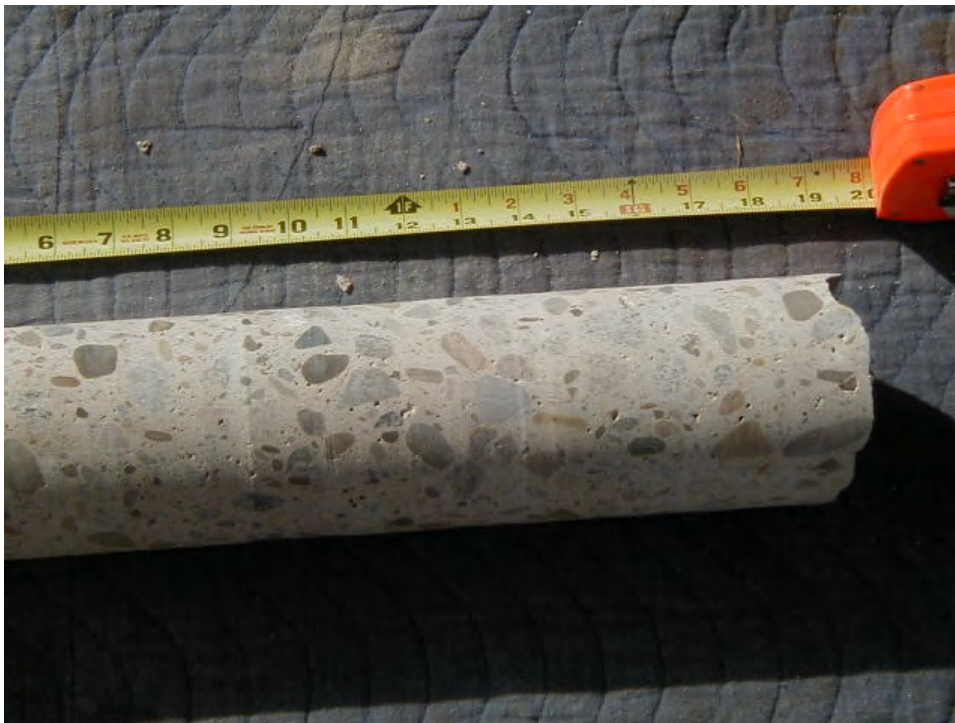
Figure 39: Close-up of portion of Core C8 that was tested.

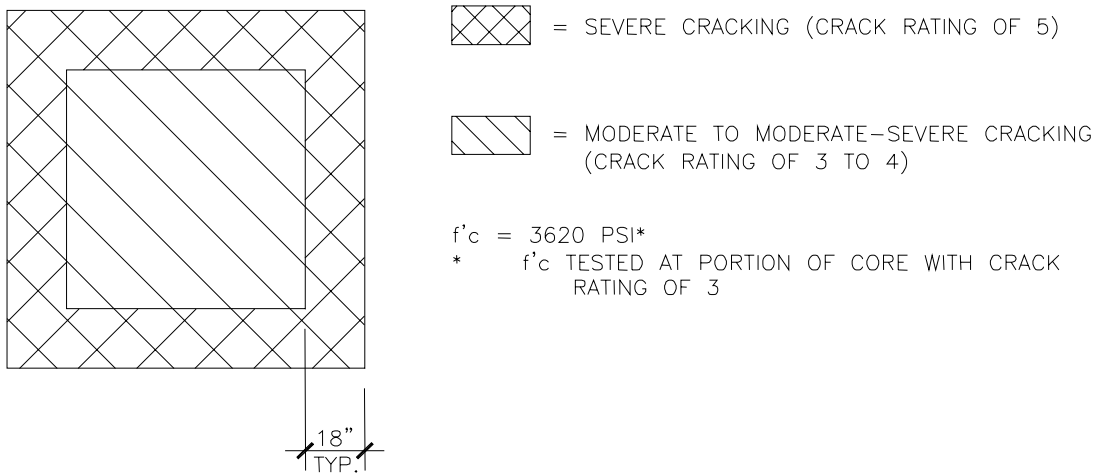
FIGURE 40 - COLUMN CROSS-SECTION BASED ON CRACKING IN CORE C47

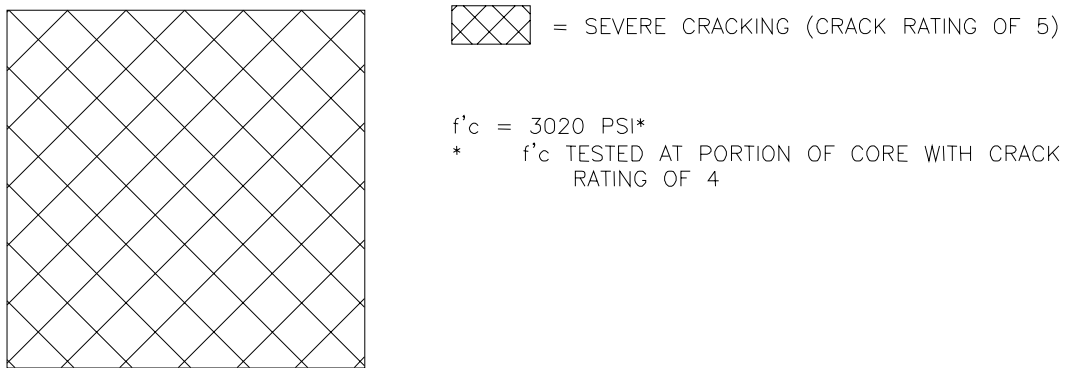
FIGURE 41 - COLUMN CROSS-SECTION BASED ON CRACKING IN CORE C16

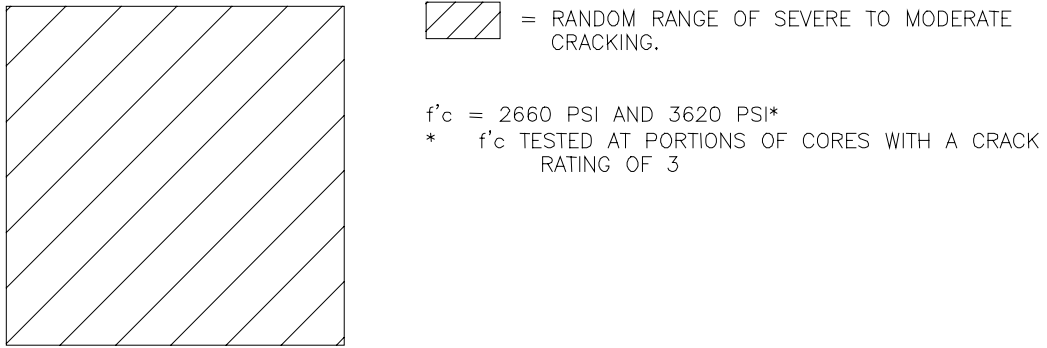
FIGURE 42 - COLUMN CROSS-SECTION BASED ON CRACKING IN CORES C11 AND C50

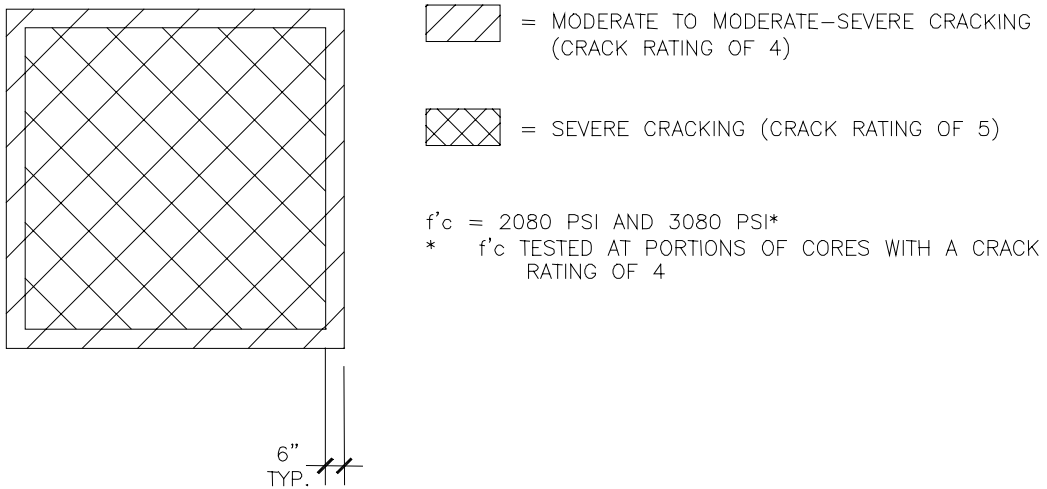
FIGURE 43 - COLUMN CROSS-SECTION BASED ON CRACKING IN CORES C33 AND C43

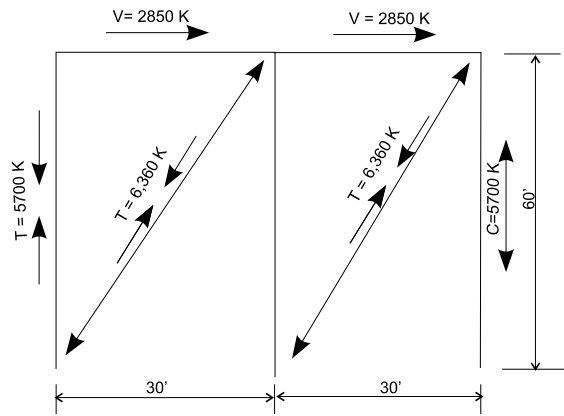
Figure 44: Strut/tie model at Bent 23.
