**SIXTH STREET VIADUCT
OVER THE LOS ANGELES RIVER
(Bridge No. 53C-1880)**

FINAL SEISMIC RETROFIT STRATEGY REPORT

**The City of Los Angeles
Bureau of Engineering**

June 2004

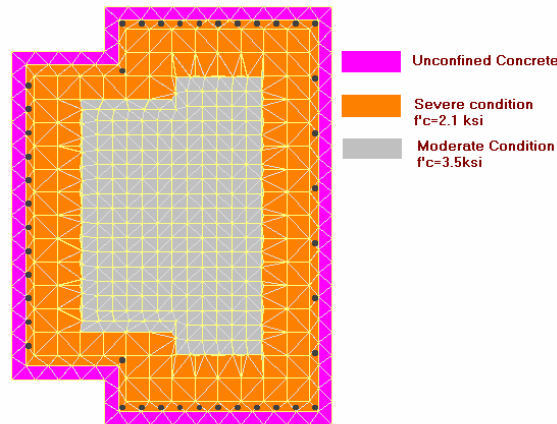
Figure 5. Model for moment-curvature analysis of an exterior column in Bent 10

The program XTRACT⁹ was used for the moment-curvature analyses. Material properties used in moment-curvature analyses of different sections were based on experimental results and the visual survey performed in the material testing report¹. A good correlation was found between the visual survey of cracking in the bridge element and condition of the concrete cores extracted from the interior of the structural elements (see Appendix G). Based on damage rating of any structural element (light, moderate or severe), appropriate concrete properties were assigned to the element (see Table 2). During the material conditions survey, ASR cracking in the columns and bent caps was found to be most severe in the outer layers of the elements, whereas cracking in the interior was moderate. Thus, for severely deteriorated elements, the outer 18 inches of concrete was assumed to be of low quality with $f'_c = 2,100$ psi and $E_c = 1,600,000$ psi. Material properties of concrete with moderate deterioration were assumed for the inner core, with $f'_c = 3,500$ psi and $E_c = 2,630,000$ psi (see Table 2). Figure 5 shows the XTRACT model for one of the exterior columns in Bent 10. Columns in Bent 10 were found to have severe or moderate-to-severe deterioration. Thus, the outer 18 inches of the column core was assigned weak material properties, whereas properties of moderate deterioration condition were assigned to the inner core as shown in Figure 5. Figure 6 shows the XTRACT model for the superstructure at Bent 6. Figure 6 indicates that the superstructure, modeled in SAP2000 by one frame element, was comprised of the deck slab and all five girders supporting the concrete deck.

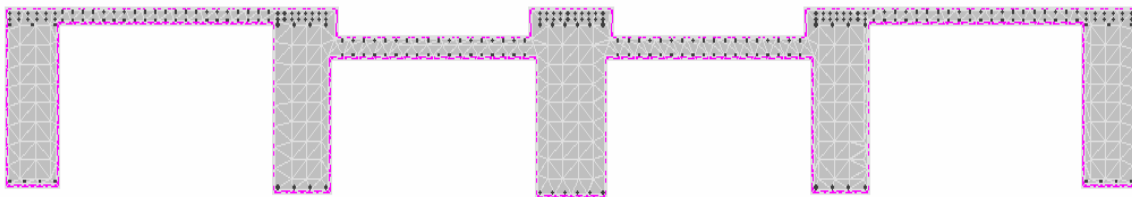
Figure 6. Model for moment-curvature analysis of the superstructure at Bent 6

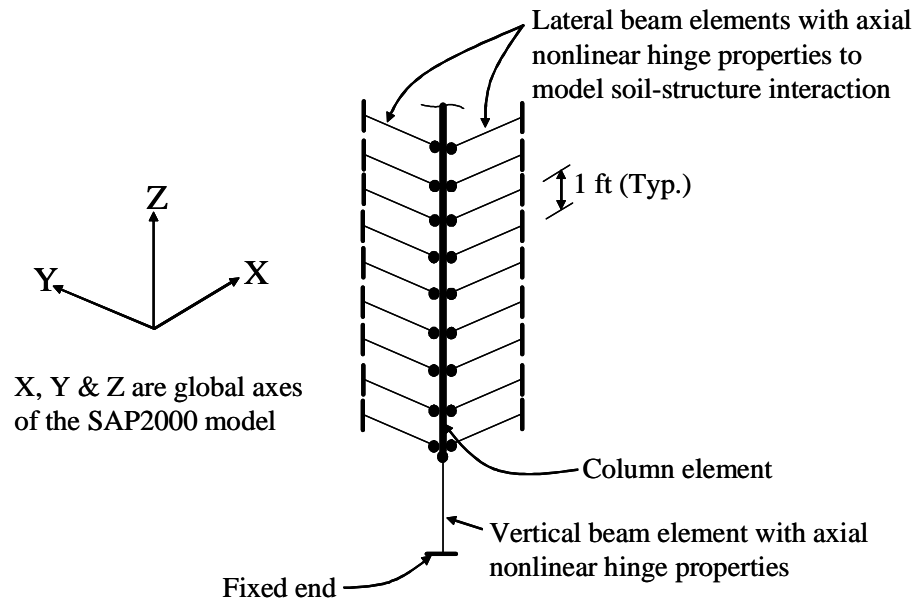
Figure 7. Modeling of soil-structure interaction in the nonlinear pushover analyses models

footings. Columns in Frames 1, 3 and 4 had lateral nonlinear soil elements that were spaced at 1 ft intervals in the vertical direction as shown in Figure 7.

Nonlinear hinge properties were also introduced for the axial direction of the vertical soil beam element shown in Figure 7; the nonlinear hinge properties were also based on geotechnical data. The ultimate soil bearing pressure capacity is 30 ksf. The foundation vertical load capacity was calculated using the soil ultimate bearing capacity multiplied by a soil-footing contact area. The soil-footing contact area was determined at each column by projection of the column cross section to the footing base at an angle of 30° with the vertical direction. The pushover analyses showed that the vertical soil springs did not reach their ultimate capacities.

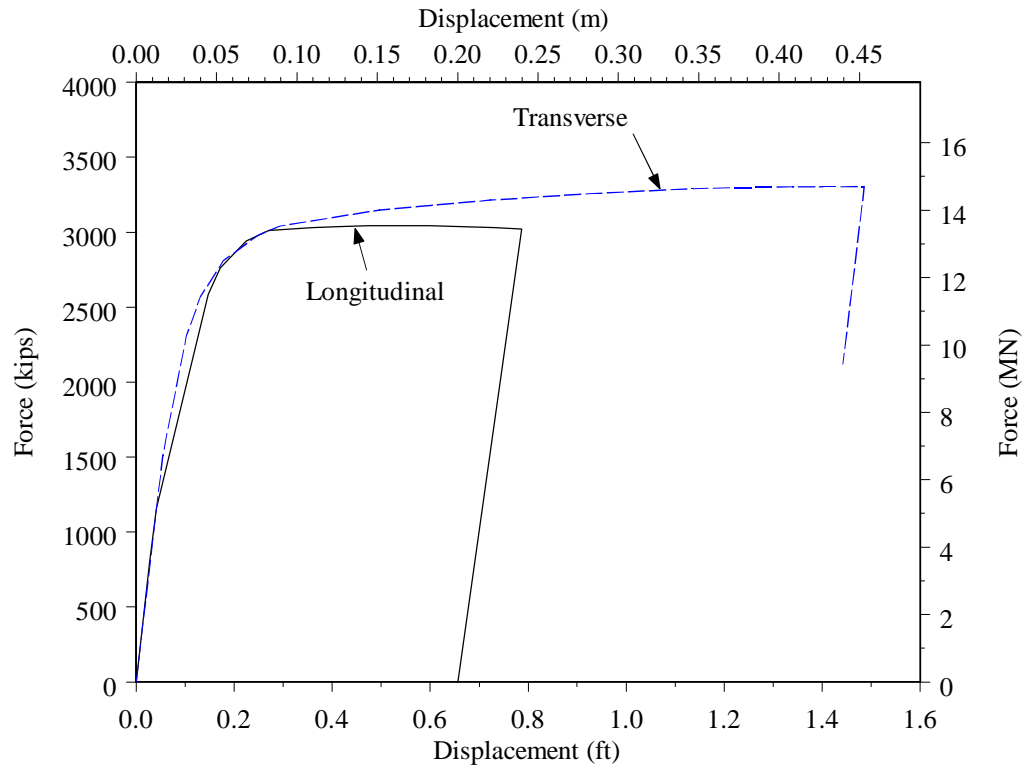
Figure 8. Longitudinal and transverse load-displacement response of Frame 1 (pushover analyses; displacement at deck level)

In Frame 1, a 3-D model was created for Bents 3 to 9 with the substructure and superstructure. The outer columns for the most part are un-symmetrically reinforced resulting in different moment capacities under positive and negative bending moments in the transverse direction as well as in the longitudinal direction. Thus, column interaction surfaces between axial forces and bending moments were calculated by XTRACT and the results were used as input for the nonlinear hinges in the SAP2000 model. The interaction surfaces were input for both the positive and negative bending directions. Similarly for the bent caps and superstructure, top and bottom reinforcement bars were not the same at any section, resulting in different moment-curvature performance under positive and negative bending moments. Also, reinforcement details were different along length of the bent cap. Thus, plastic hinges that were assigned to the bent cap in the nonlinear analysis models had different input data for positive and negative bending. Up to four plastic hinges were modeled in each bent cap since three columns exist in a typical bent. Pushover analysis was performed in the longitudinal direction of the bridge by application of increasing displacement at the superstructure level until the above-mentioned “collapsible mechanism” is reached. Similarly, transverse pushover analysis was performed by application of increasing transverse displacement at top of the columns. More details about the nonlinear pushover analyses can be found in Appendix E and the retrofit pre-strategy report². These include undeformed shapes of the models, deformed shapes with locations of the plastic hinges that formed as a result of the pushover loads, bending moments, shears and axial forces. Maximum displacement capacities are also given in Appendix E. Figure 8 shows the base shear, or seismic force, versus top displacement in both longitudinal and transverse directions as obtained from the pushover analyses of Frame 1. Figure 9 shows the deformed shape of Frame 1 at longitudinal ultimate displacement capacity, or in other words when the collapsible mechanism was reached under longitudinal pushover loading. Locations of plastic hinges are also shown in Figure 9 as well as locations of first columns that would fail.

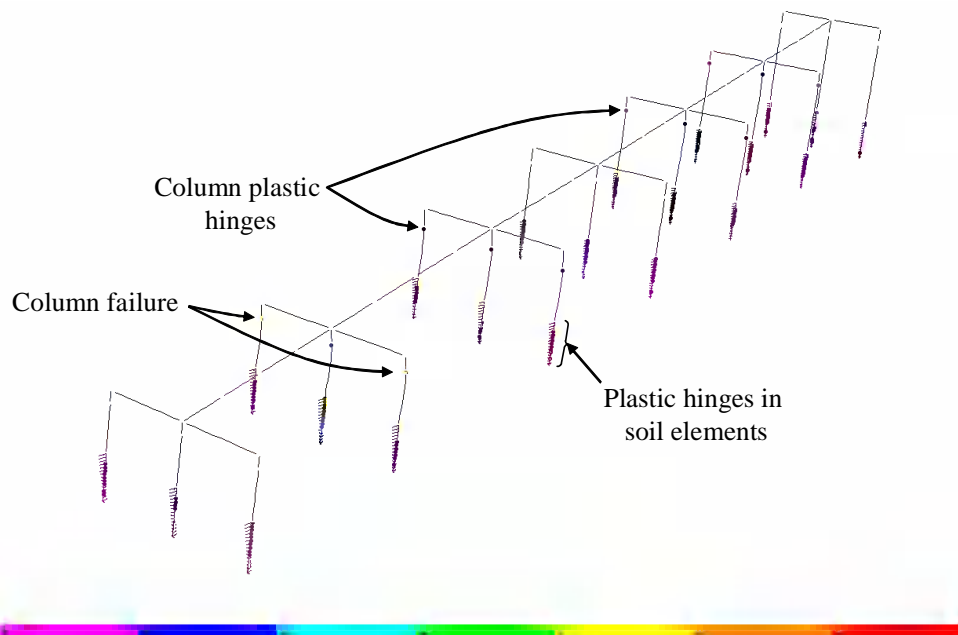
Figure 9. Deformed shape of Frame 1 at longitudinal ultimate displacement (pushover analysis)

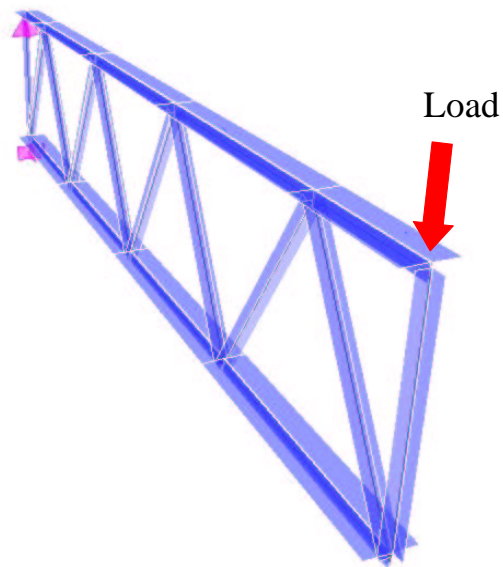
Figure 13. Breakout model of a laced steel member

To determine the added shear flexibility that the lacing contributes to fully composite action for a typical laced member, a breakout model was developed of a cantilever member subjected to linear bending. The breakout model is shown in Figure 13. From this breakout model it was found that a typical laced member from the arch spans is 30% more flexible than the same member with fully composite behavior based on the flange areas. In the SAP2000 software, the local beam element stiffness matrix includes separate flexure and shear terms, with the amount of shear flexibility controlled by a shear area multiplier. For typical rolled or built-up members the shear area is based on the web area and most of the deformations are associated with flexure. However, with laced members the additional shear flexibility is significant and should be included in the model. A dimensionless shear area multiplier was determined based on analyses of the breakout model shown in Figure 13 and a second similar breakout model comprised of a single beam element. This shear area multiplier was applied to beam elements used in the global model of the main spans. Thus, all of the lacing was included in the breakout model and represented by a single beam element in the global model, but with the correct flexure and shear behavior of the detailed laced member. The same dimensionless shear multiplier was used for all laced members, providing additional shear flexibility to the beam members associated with deformation of the lacing. The above-mentioned second breakout model was developed of a single beam element, with shear modification, to confirm that its behavior under flexure, shear, and a combination of both flexure and shear, agreed with the more detailed laced model. Hand calculations were also used to verify the results for pure shear, pure bending and for linear bending. It should be noted that under pure bending the shear modification has no effect on the response of the member, with identical results to a fully composite section, as expected.

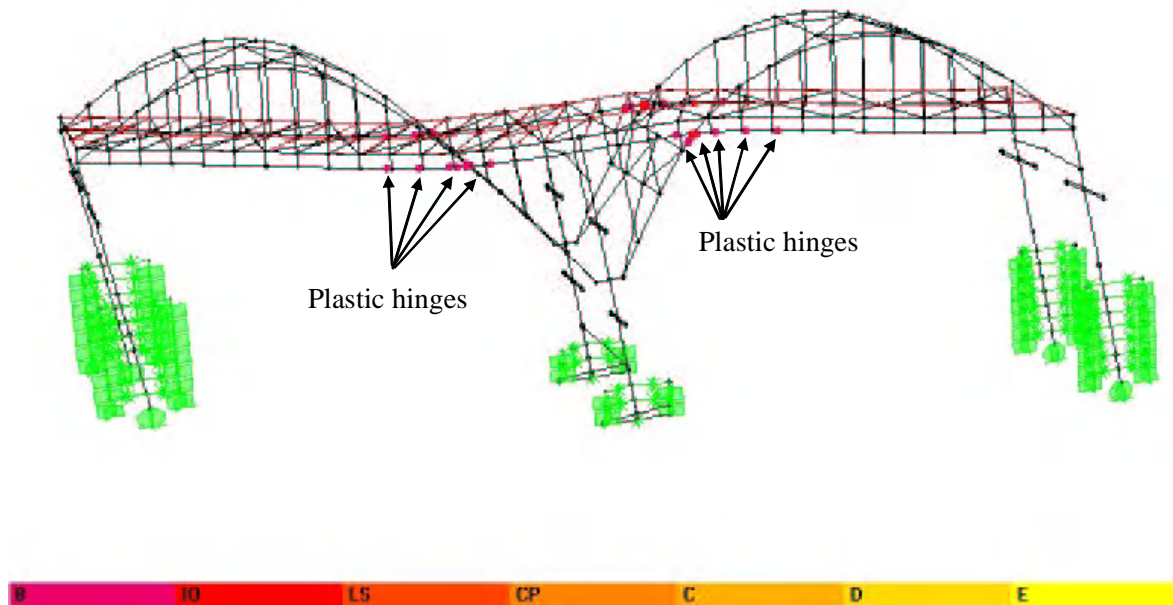
Figure 20. Longitudinal pushover model for arch spans of the as-built structure

Figure 20 shows the deformed shape of the model at the ultimate longitudinal displacement of 1.18 ft. The deformed shape clearly indicates the relatively rigid triangle defined in Figure 2 as “OAB”. Figure 20 also shows the location of plastic hinges that have formed in the steel arch ribs and tension tie members, indicated by solid circles with different color codes for different limit states. The color code ranges from onset of yielding to fracture limit state; the color code is also shown in Figure 20. Plastic hinges that develop in the steel arch ribs and tension ties are concentrated in the vicinity of the arch rib-tie junction, as was discussed before. This is because of the relatively large longitudinal displacements of the as-built main spans, which results in rigid body rotations of the stiff triangle “OAB” (shown in Figure 2). This rigid body rotation results in high rotation, curvature and strain demands in the steel members at Points “A” and “B” shown in Figure 2.

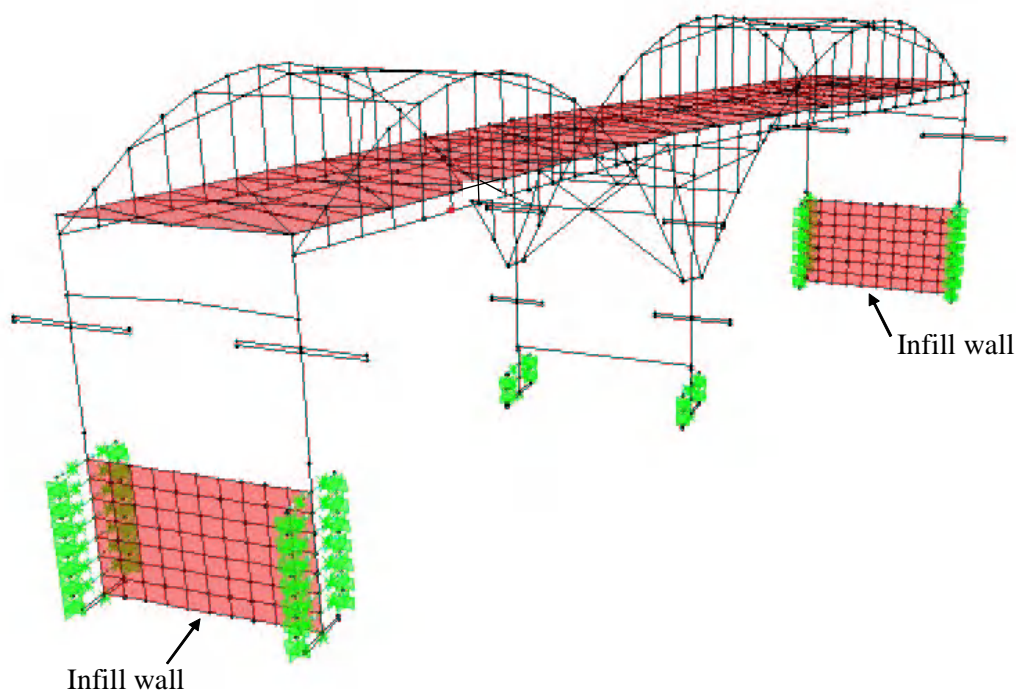
Figure 21. Global model for arch spans of the retrofitted structure

The model used for analysis of the as-built main spans (see Figure 16 and Figure 17) was modified and used for analysis of the retrofitted structure. Shell elements were included between columns in the West and East River Piers to represent the proposed infill walls. In addition, plastic hinge models, similar to that shown in Figure 14, were added at the bottom of the West and East River Pier columns as foundation retrofit confines lap-splices, allowing plastic hinges to develop under longitudinal seismic loading. Figure 21 shows the model used in modal, linear elastic and nonlinear time-history analyses, as well as pushover analyses of the retrofitted arch spans.

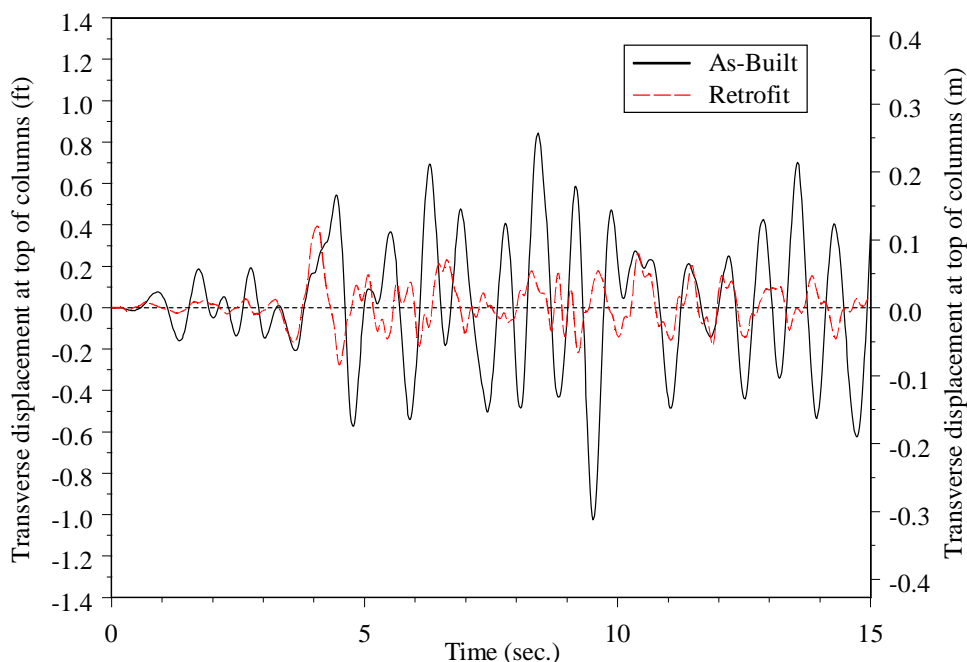
Figure 24. Transverse displacements at top of the East River Pier for the as-built and retrofitted structures

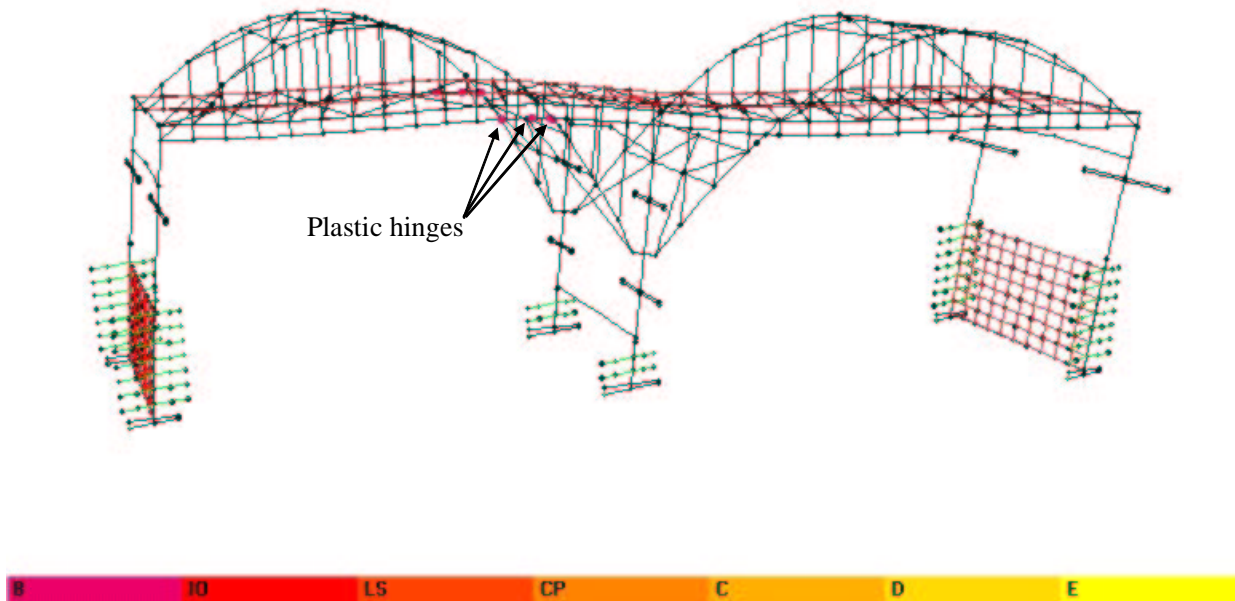
Figure 25. Longitudinal pushover model for arch spans of the retrofitted structure

Figure 25 shows the deformed shape from the pushover model of the retrofitted structure at maximum longitudinal displacement demand of 0.89 ft from time-history analysis. As for the as-built structure, the model was pushed to maximum displacement demand levels rather than to failure displacements. The objectives of pushover analyses of the arch spans were to verify the plastic hinge mechanism found from nonlinear time-history analyses and to show that fewer plastic hinges develop in the retrofit model compared to the as-built model. Comparison of plastic hinges shown in Figure 20 and Figure 25 clearly indicates that fewer plastic hinges form in the arch rib and tension tie members for the retrofitted structure compared to the as-built structure at maximum displacement demands. Also, time-history analyses indicate reduced ductility demands in these members for the retrofitted structure.

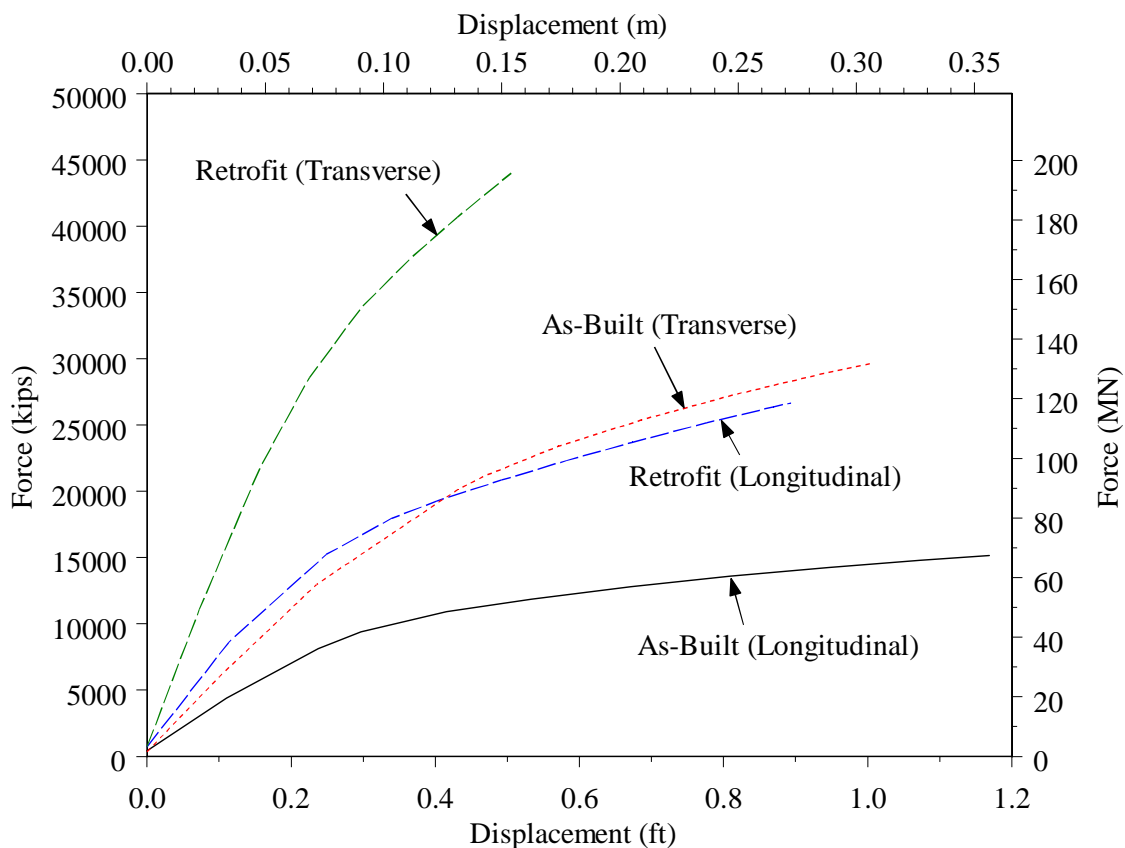
Figure 26. Load-displacement response of the main spans (pushover analyses)

Figure 26 shows load-displacement curves obtained from pushover analyses of the as-built and retrofitted arch spans. The purpose of this figure is to illustrate effects of the proposed retrofit in increasing stiffness and strength of the arch spans. Comparison of the curves shown in Figure 26 indicates that the proposed retrofit would significantly reduce seismic displacements and result in less inelastic strains in different elements of the retrofitted structure. More analysis results can be found in Appendix E.

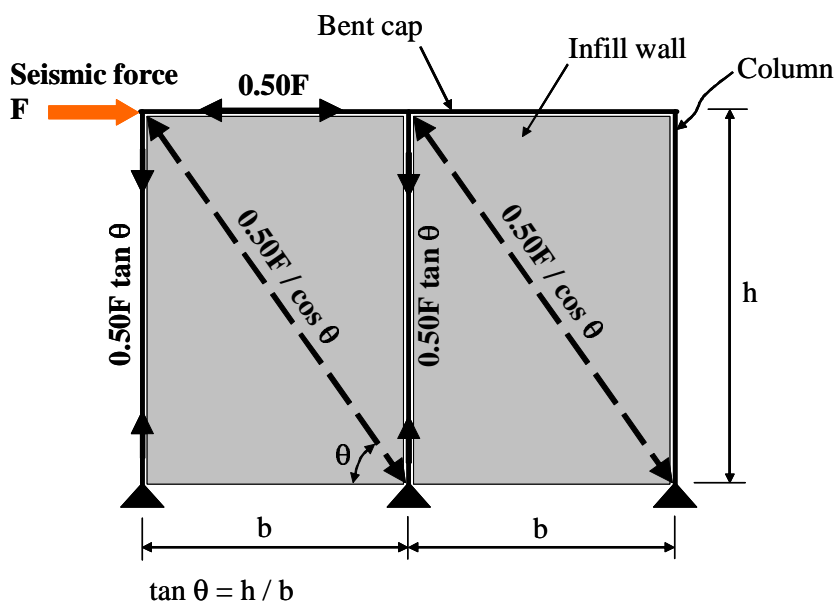
Figure 27. Strut-and-tie seismic force transfer mechanism inside infill walls (Alternative 1)

Analysis of the infill walls under transverse seismic forces can be simplified with a strut-and-tie model as illustrated in Figure 27. Figure 27 shows that the seismic force, F , is transferred to the foundation by means of diagonal compression struts in the infill walls. In fact, tension ties would also exist in the shear wall, but only compression struts are assumed for simplification purpose. To satisfy force equilibrium, high shears would be transferred between the infill walls and columns. It has been shown in the material testing report that force transfer mechanisms, similar to that shown in Figure 27, could result in transfer of shear stress as high as 175 psi between columns and the adjacent infill walls¹. The deteriorated concrete in the columns could prevent transfer of such high shear stresses and thus result in extension and widening of existing cracks in the columns. This could result in further weakening of the structure to resist seismic forces, or even gravity loads after the earthquake.

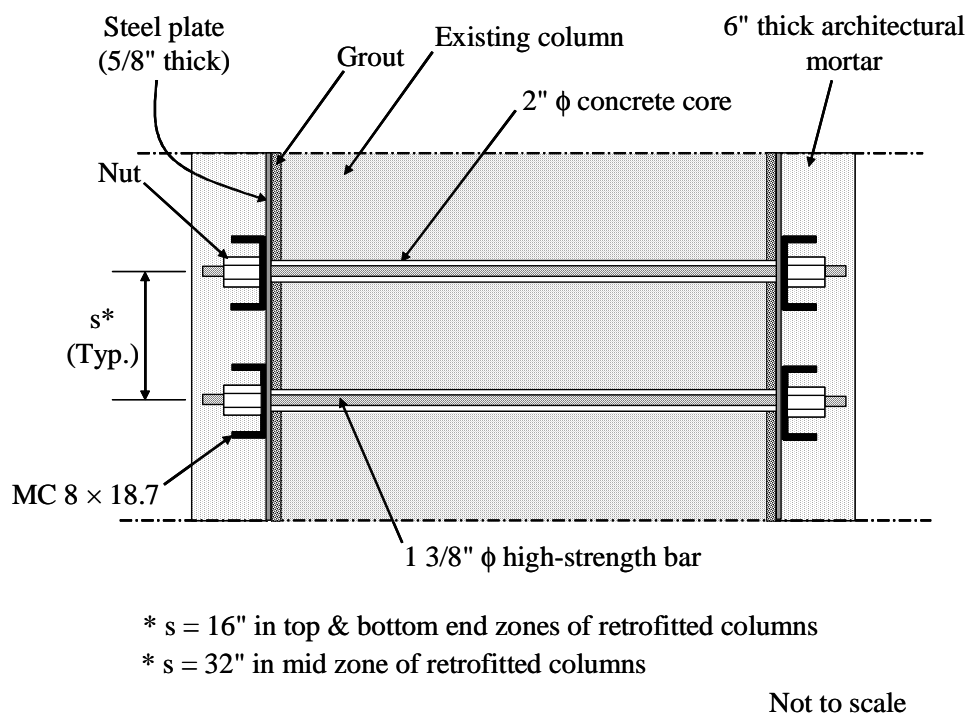
Figure 28. Steel encasement of columns

Figure 28 shows a schematic elevation view of the steel plate encasement proposed in Alternative 2. All surfaces of a retrofitted column will be encased by 5/8" thick steel plates. The columns are not circular or rectangular, but have complicated geometry; an example of an exterior column with steel casing is shown in Appendix B (see typical details of steel casings).

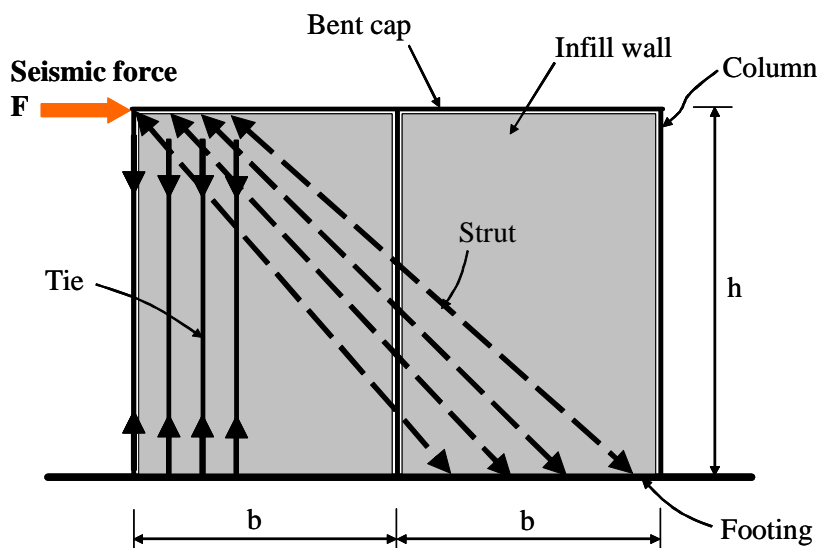
Figure 29. Strut-and-tie seismic force transfer mechanism inside infill walls (Alternative 2)

the effect of presence of footing underneath shear walls on shears transferred between the columns and the shear walls; these qualitative analyses were simplified and not intended for design purposes. Assuming a seismic force $F = 6,000$ kips, the analyses showed that the total shear transferred between the columns and the walls would be approximately 5,300 kips and 4,000 kips in Alternatives 1 and 2, respectively. Finite element models, reactions and contour plots of vertical forces per unit width, as obtained from SAP2000, are shown in Appendix E. With reduced shear stress demands at wall-column interface and with steel encasement of significantly deteriorated columns, the high strength bars that connect the infill walls and existing columns, as proposed in Alternative 2 (see typical steel casing details in Appendix B), should be structurally efficient.

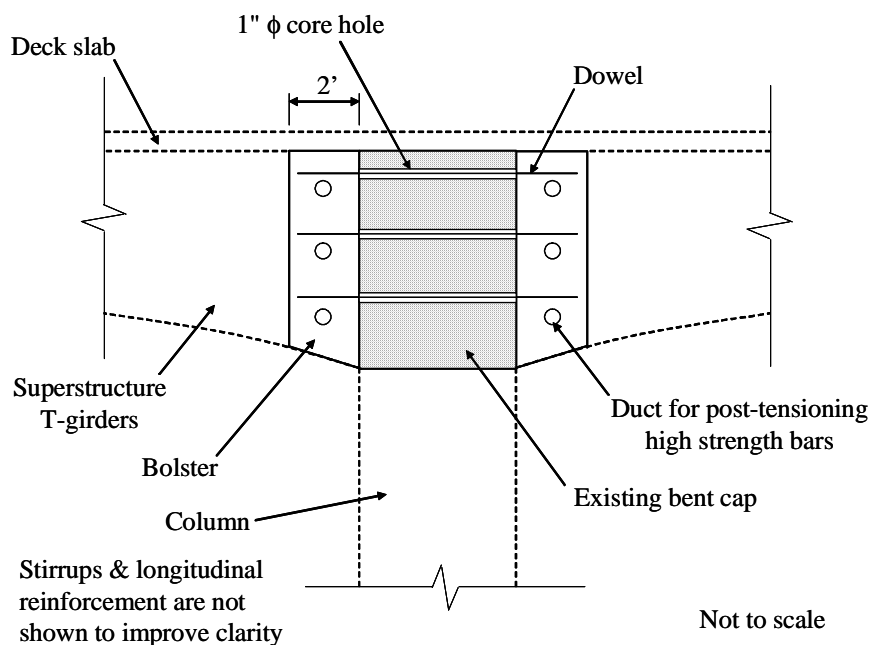
Figure 30. Retrofitting of bent caps by concrete bolsters

As mentioned earlier, steel casing of the columns would also require increasing flexural strength of some bent caps to ensure that plastic hinges would form in the columns under seismic loading. This is because the existing bent caps have limited ductility capacity due to poor detailing. Clearly, no retrofitting is needed for bent caps at locations of the infill walls. However, cap beams at bents with no infill walls, but with retrofitted columns or existing columns in relatively good conditions would need to be retrofitted based on displacement D/C ratios and locations of potential plastic hinges in the bent caps (as obtained from analyses of the as-built structure). Alternative 2 includes retrofitting of three bent caps (Bents 8, 16 and 32) by means of concrete bolsters constructed on both sides of the bent cap as shown in Figure 30. These bolsters will be constructed on sides of the bent cap and around the longitudinal superstructure T-girders. The bolsters will be bonded to the existing bent caps by dowels that run through pre-drilled cores in the existing bent cap. Continuity of the concrete bolsters along length of the bent cap would be achieved by post-tensioning of high strength bars that would run through pre-drilled cores in the superstructure girders (see Figure 30). The post-tensioning bars would be anchored at their ends by exterior steel plates; these exposed plates and the bars would be concealed by mortar as for the column steel jackets.

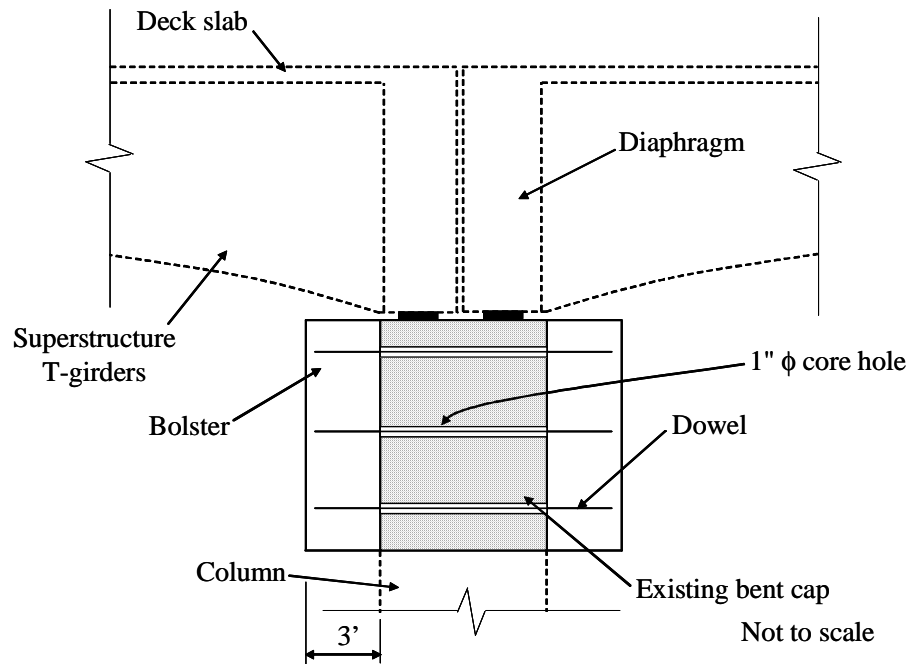
Figure 33. Alternative 4 retrofit of bent caps at expansion joints (two simply supported spans)

Expansion joints exist in the two adjoining superstructure girders at locations of some bents; these are designated by “E/E” in the drawings given in Appendix B. Figure 33 shows the proposed retrofitting of bents caps at locations of expansion joints with two simply supported superstructure spans. Figure 33 shows that retrofitting of the existing bent caps can be achieved by bolsters along sides of the existing cap beams. The bolsters are bonded to the existing bent cap by dowels as shown in Figure 33. Figure 34 shows bent caps with an expansion joint at only one of the two adjoining spans (bent caps designated by “E/F” in drawings of Appendix B). These bent caps will be retrofitted by concrete bolsters and dowel reinforcement as shown in Figure 34. Negative flexural moment capacity will be increased by removal of the top portion of the existing bent cap; this will be followed by placement of more top reinforcement and new concrete (see Figure 34).

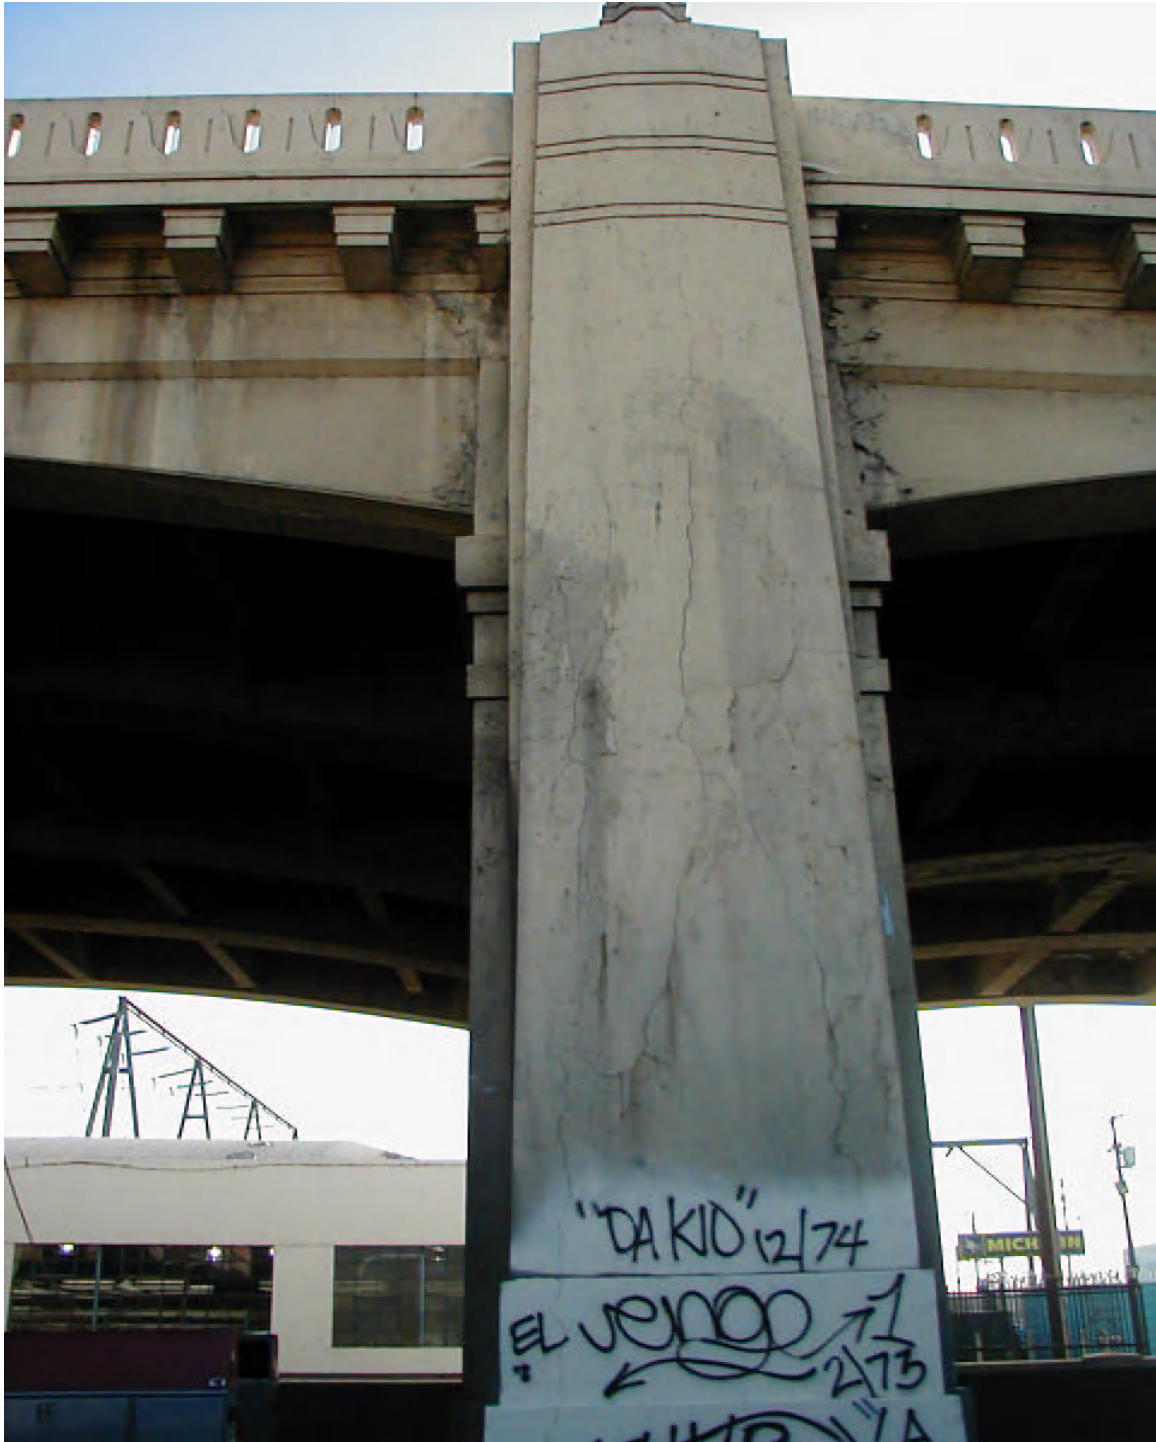
Figure F.7. Typical cracking on outside face of columns and superstructure girders

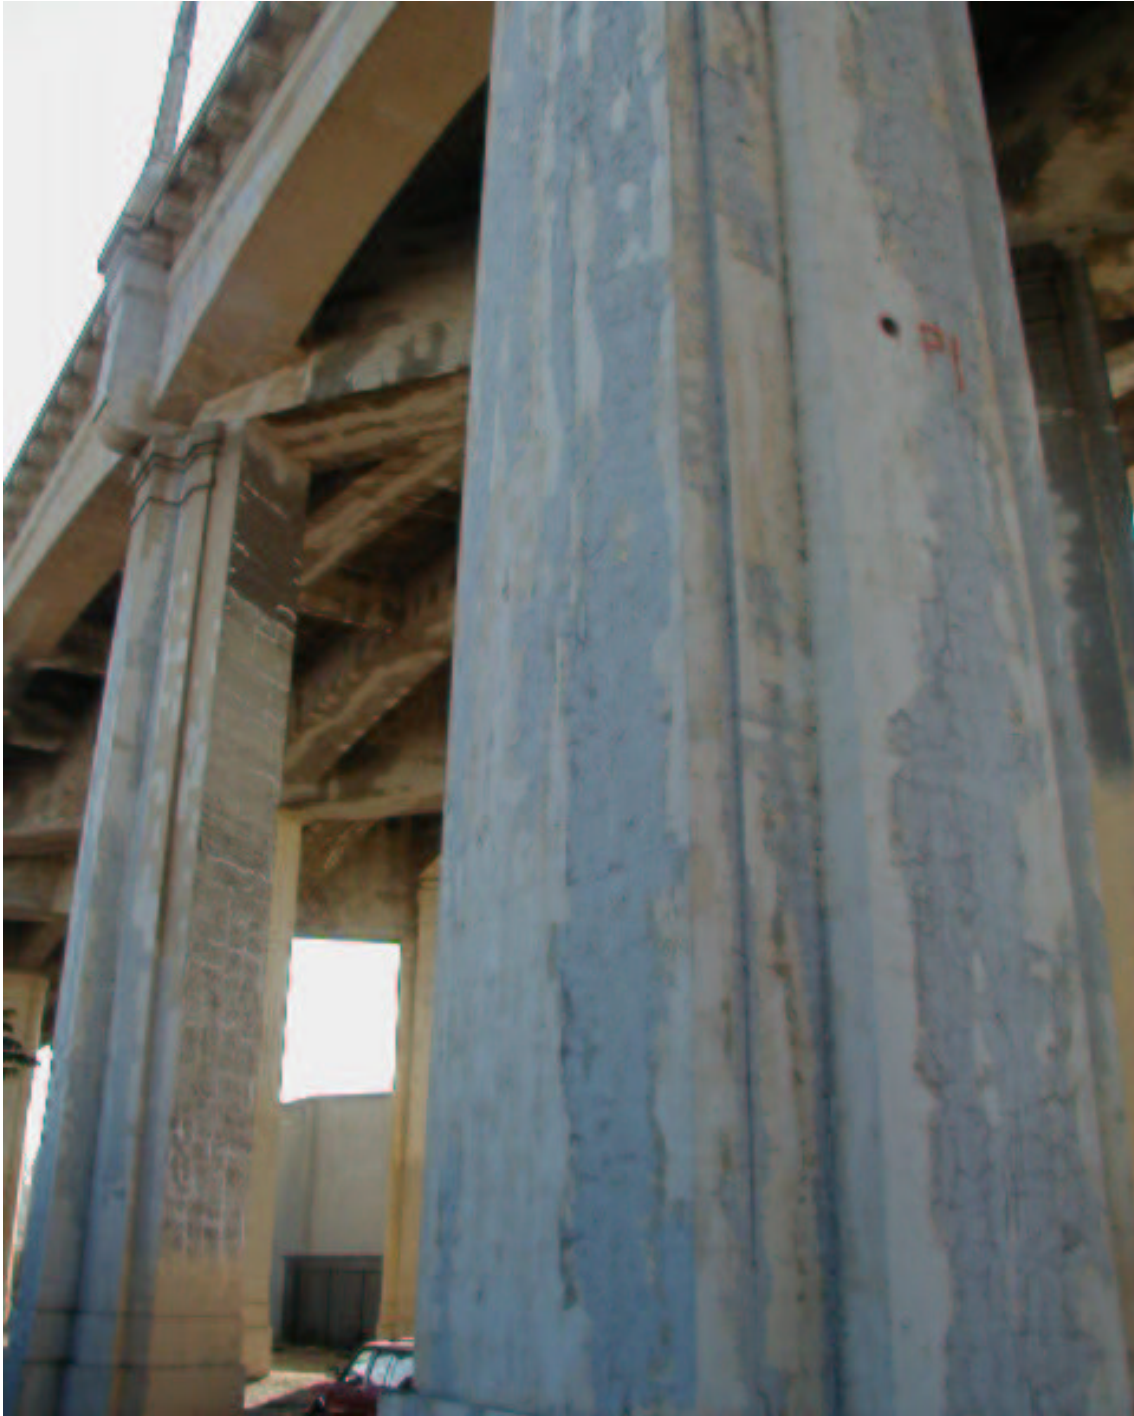
Figure F.8. Typical condition of columns in the east approach spans

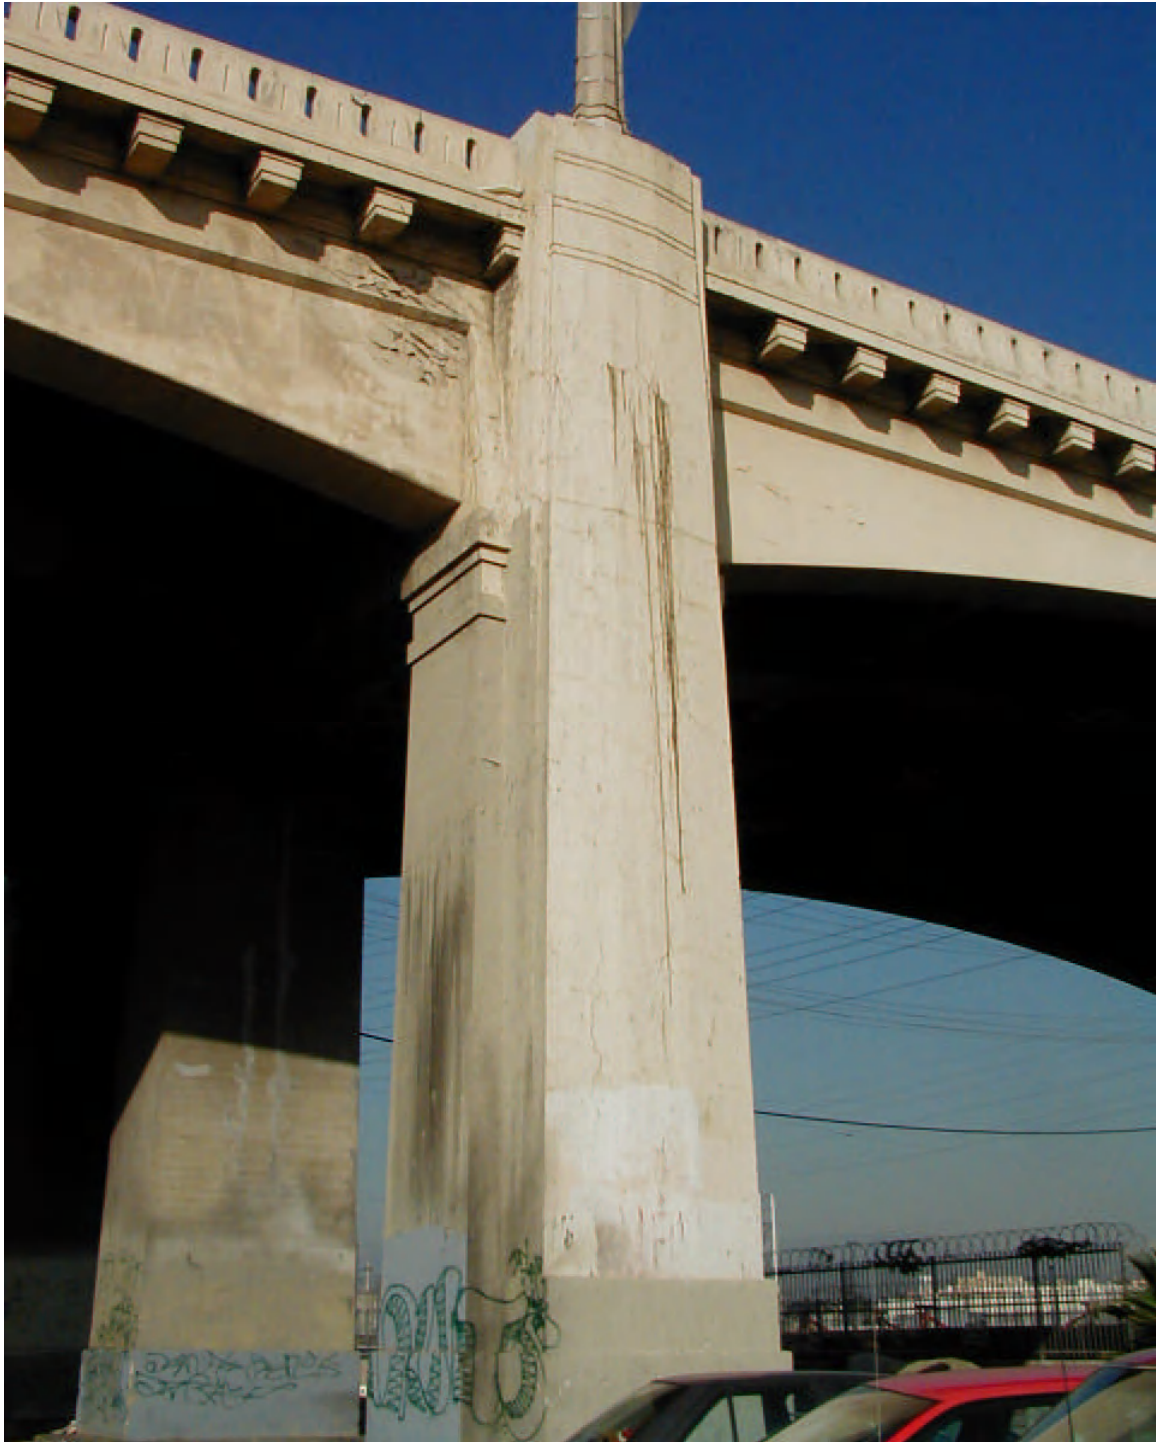
Figure F.9. Typical horizontal cracks in column at level of bent cap

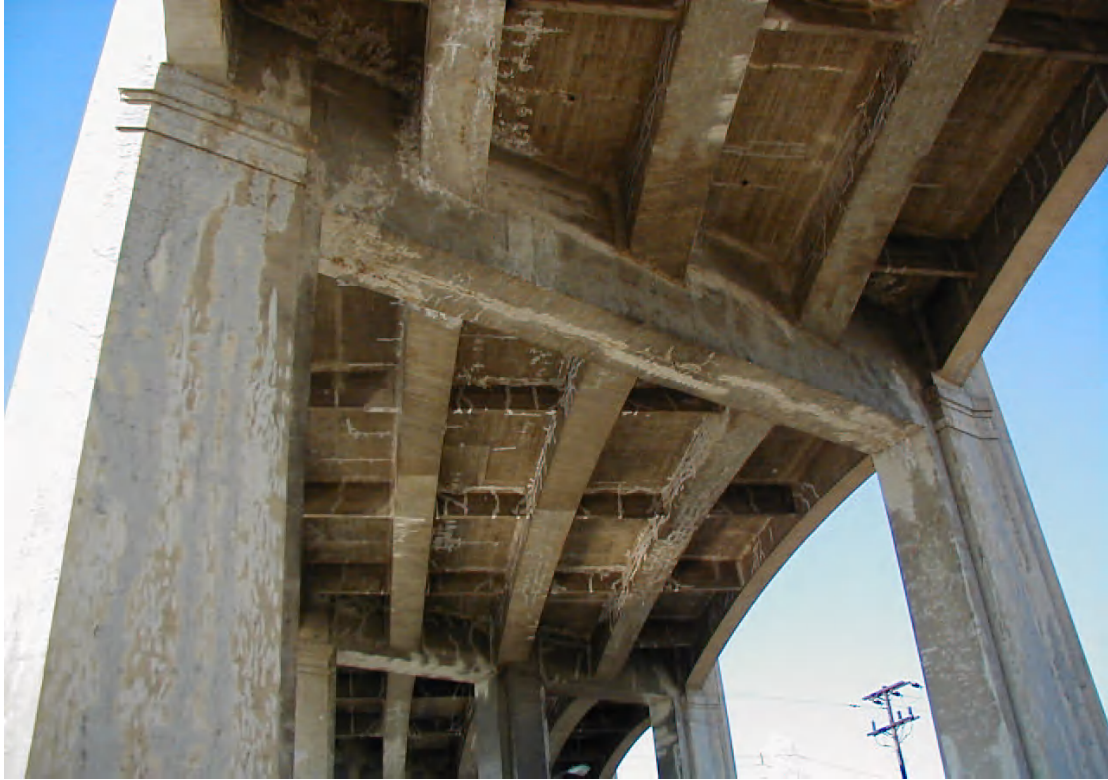
Figure F.10. Typical cracking pattern in bent caps and girders

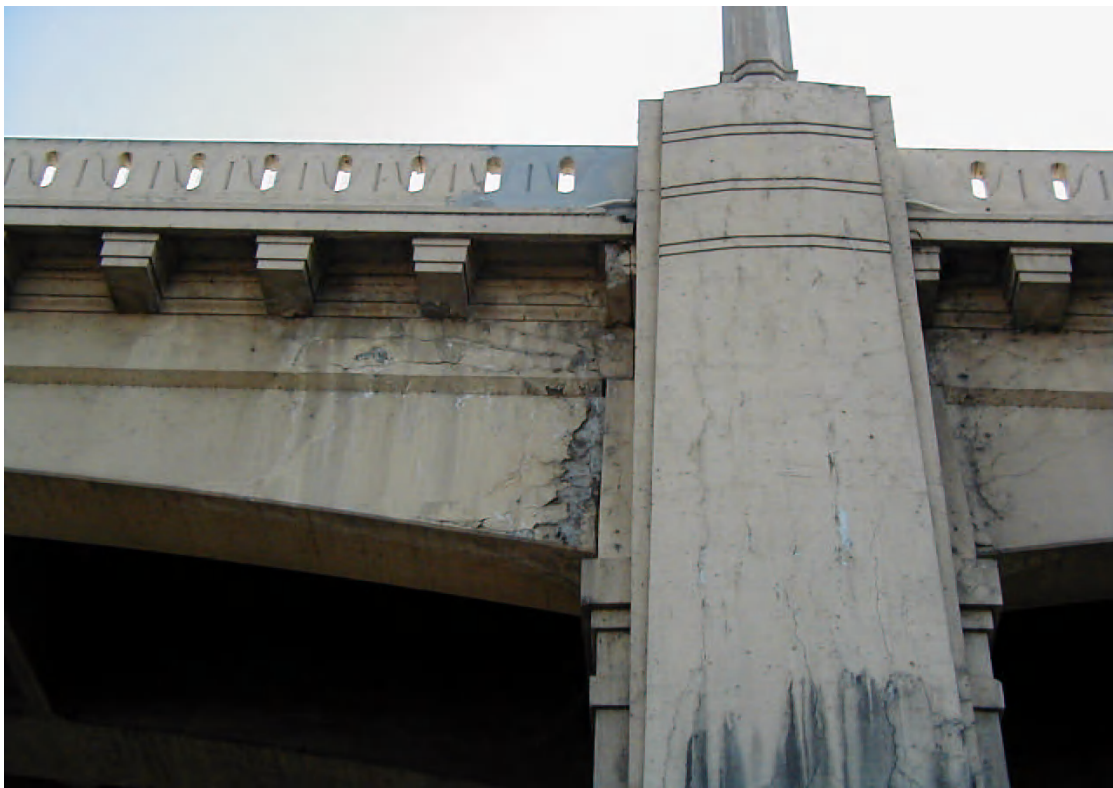
Figure F.11. Cracking in webs of superstructure longitudinal girders

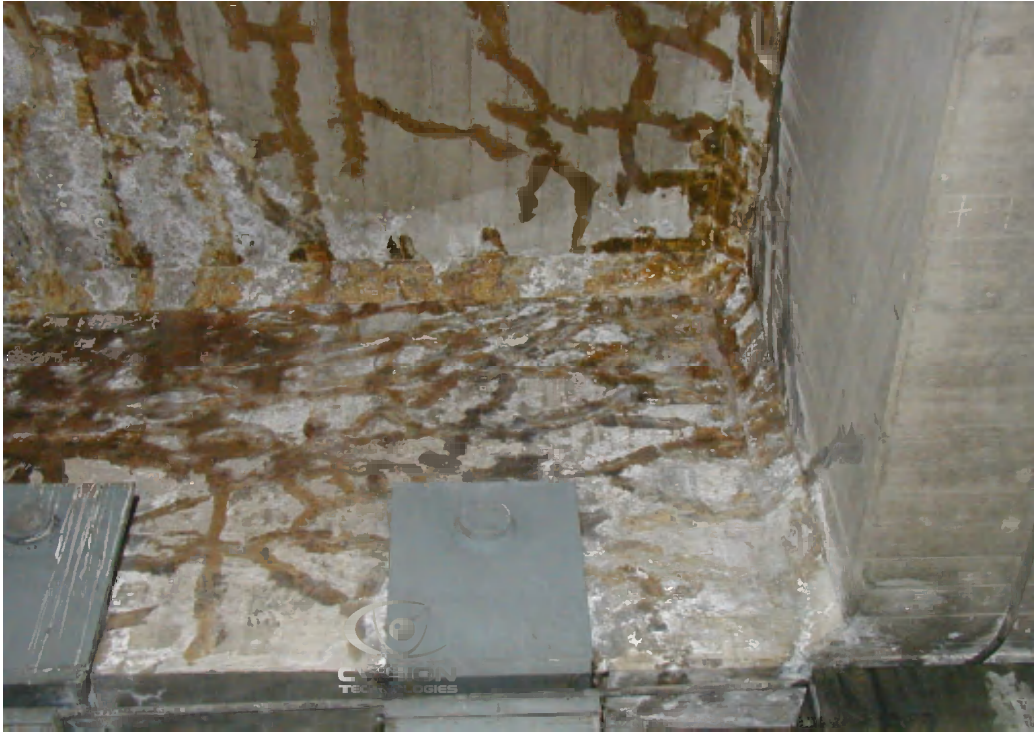
Figure F.12. Severe cracking in bent cap and deck soffit

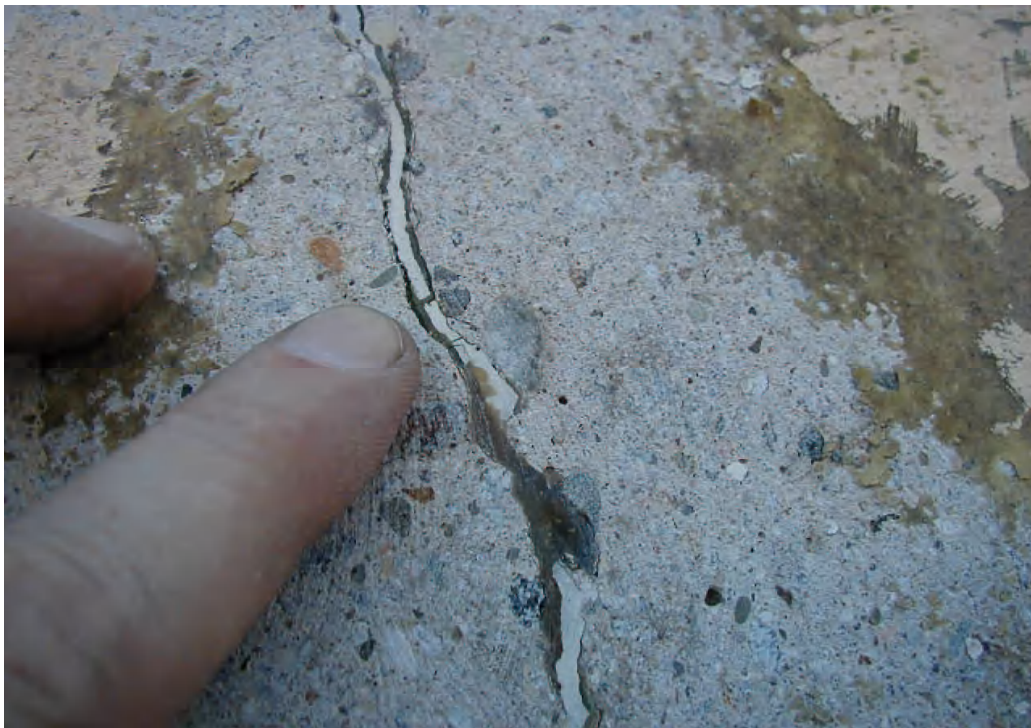
Figure F.13. Reopened crack at surface of column with two generations (colors) of epoxy injection
