**SIXTH STREET VIADUCT
OVER THE LOS ANGELES RIVER
(Bridge No. 53C-1880)**

FINAL SEISMIC RETROFIT STRATEGY REPORT

**The City of Los Angeles
Bureau of Engineering**

June 2004

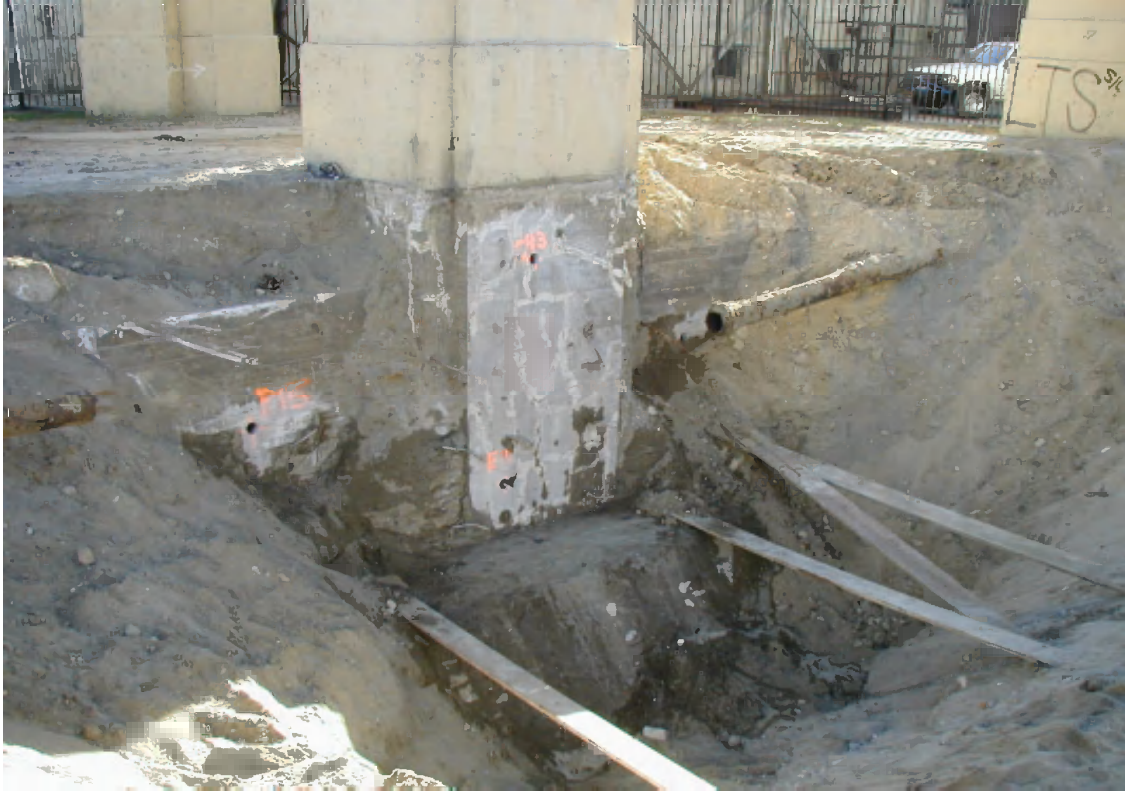
Figure F.14. Cracks in column below ground level

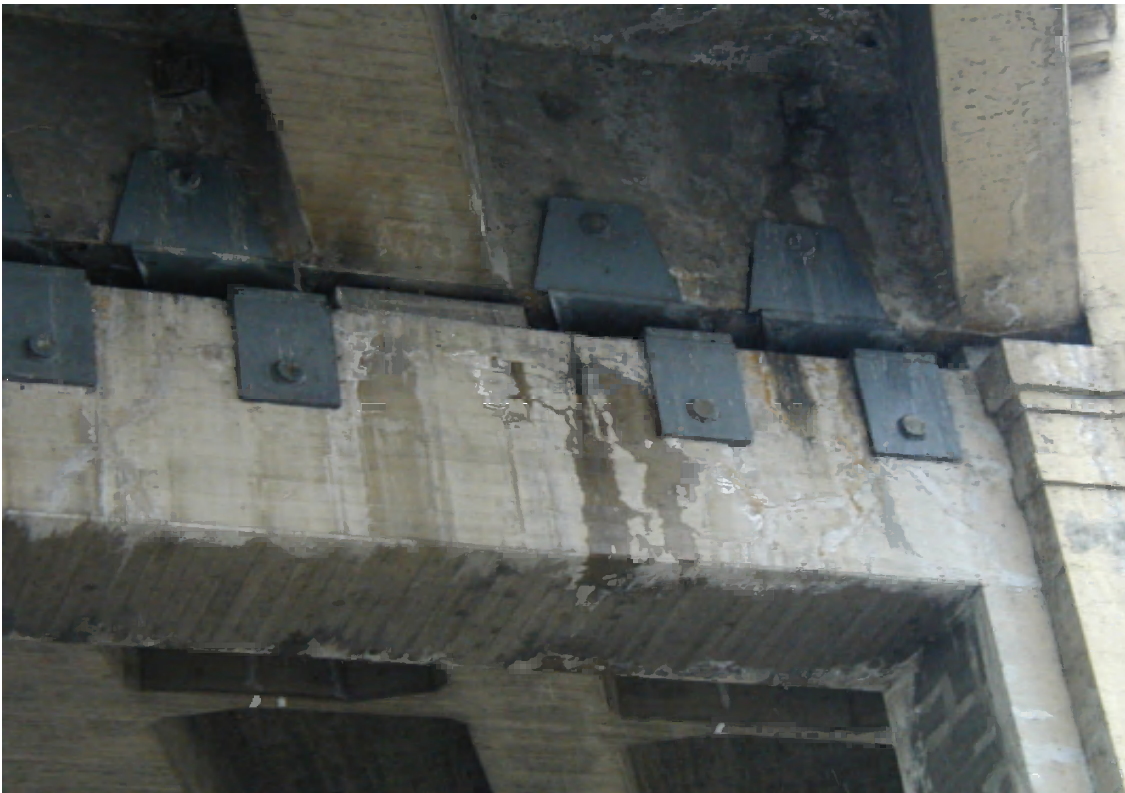
Figure F.15. Water leaking from the deck at an expansion joint

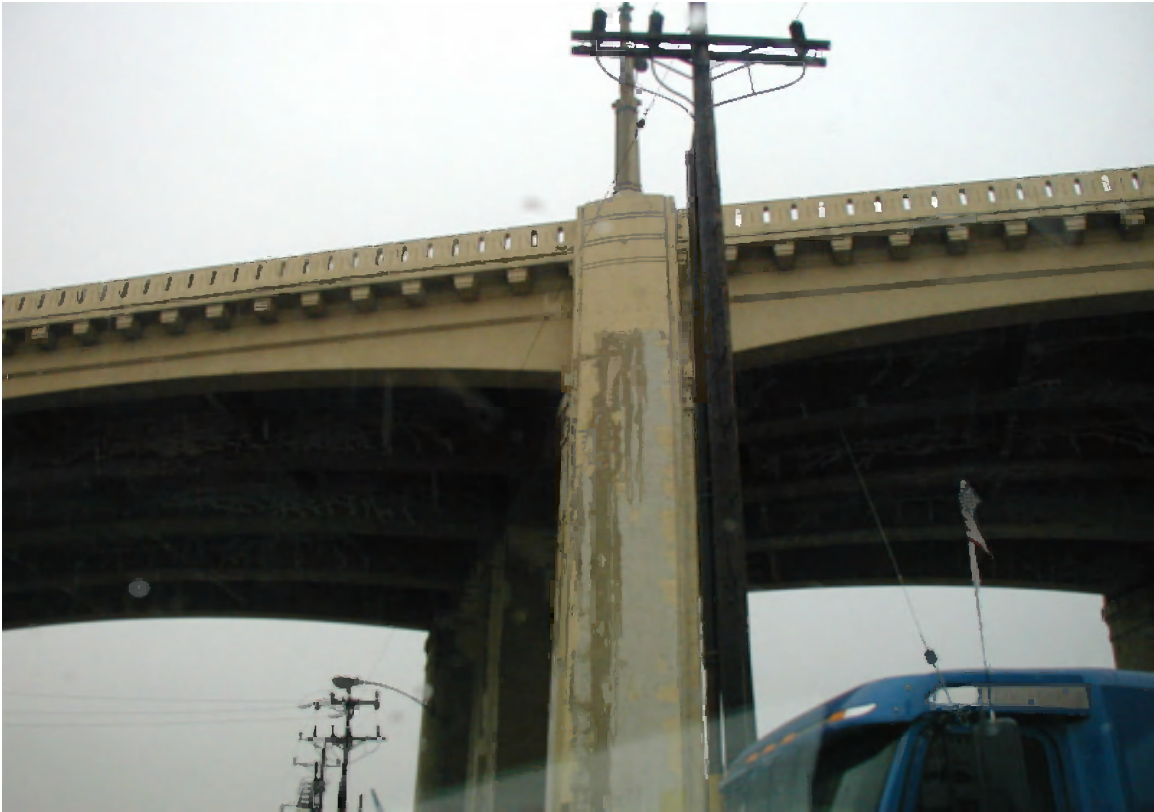
Figure F.16. Water leaking from a typical horizontal column crack at bent cap

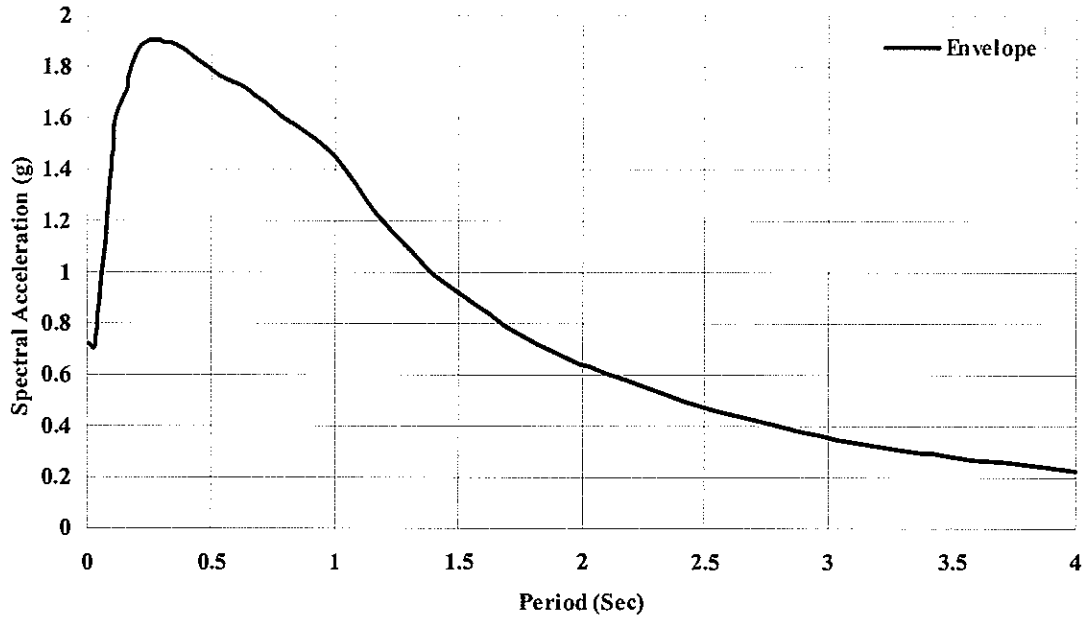
Figure 3. Recommended Enveloped ARS Curve

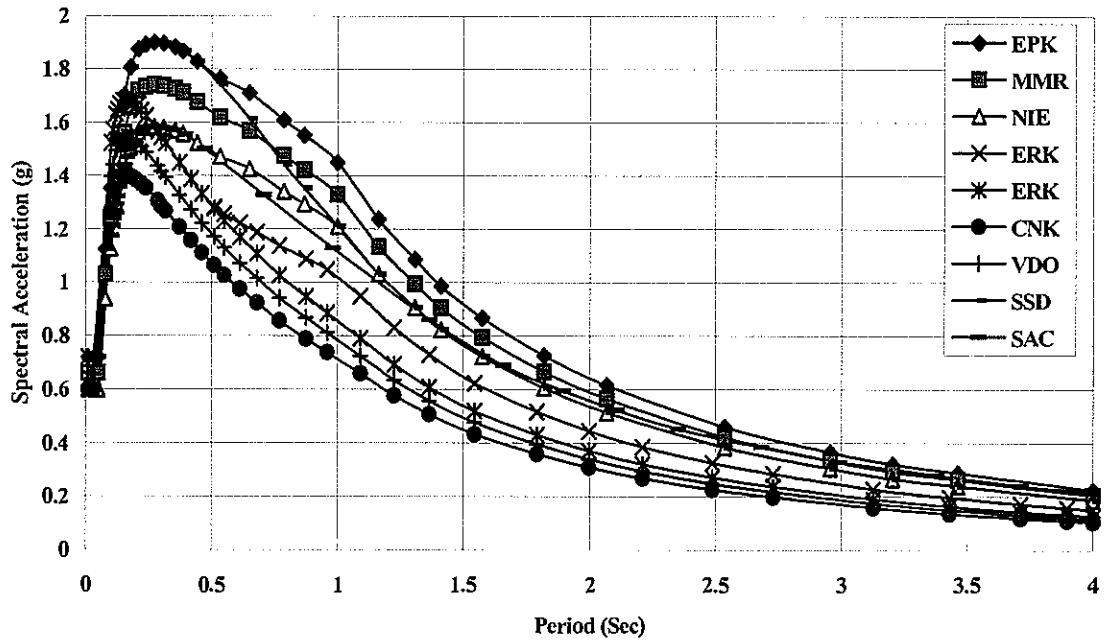
Figure 4. ARS Curves for each fault

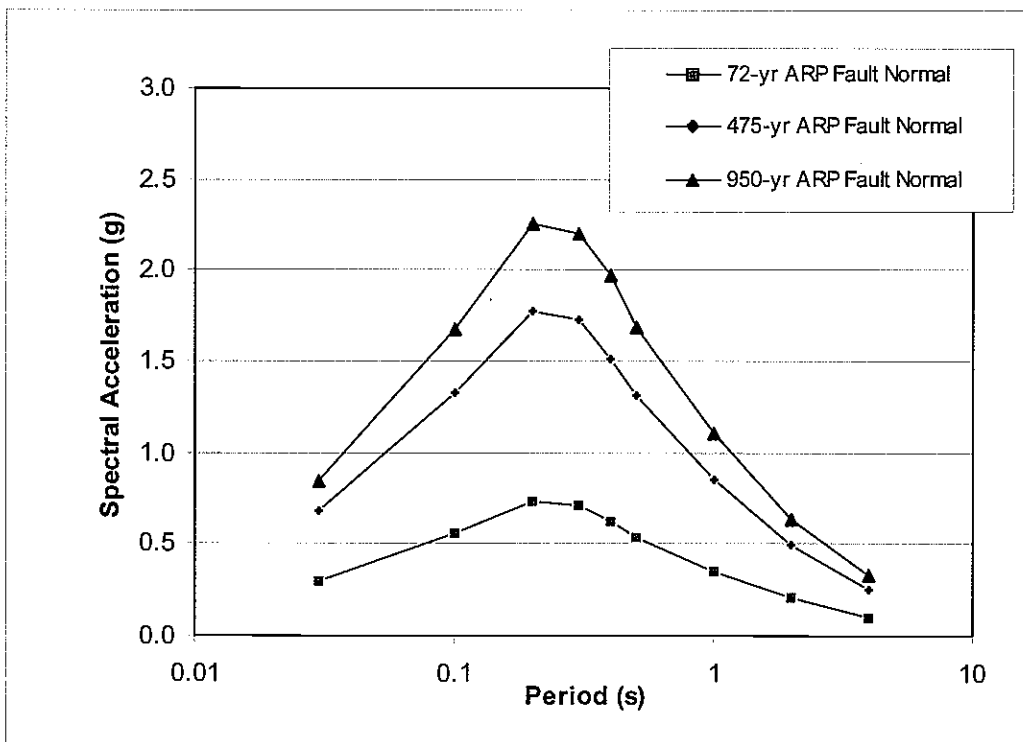
Figure 6. Uniform Hazard Response Spectrum

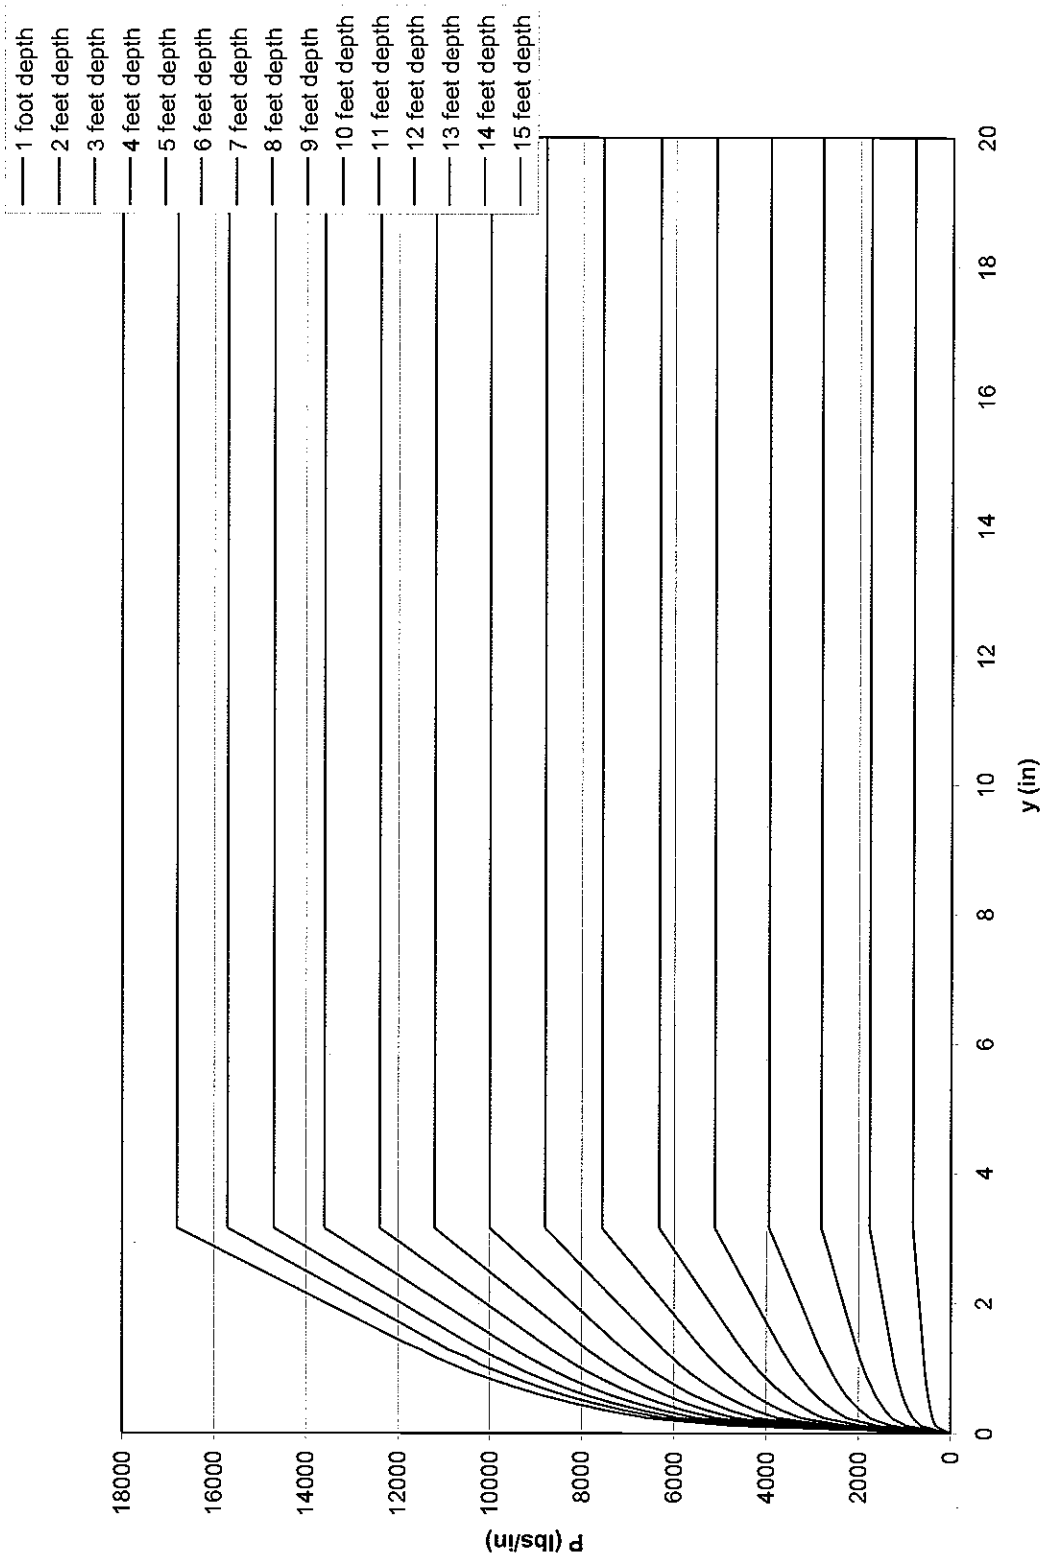
Figure 7. Unit P-y Curves
